Proceedings of the National Seminar & Exhibition on Non-Destructive Evaluation

NDE 2009, December 10-12, 2009

Vibration Diagnostics as NDT Tool for Condition Monitoring in Power Plants

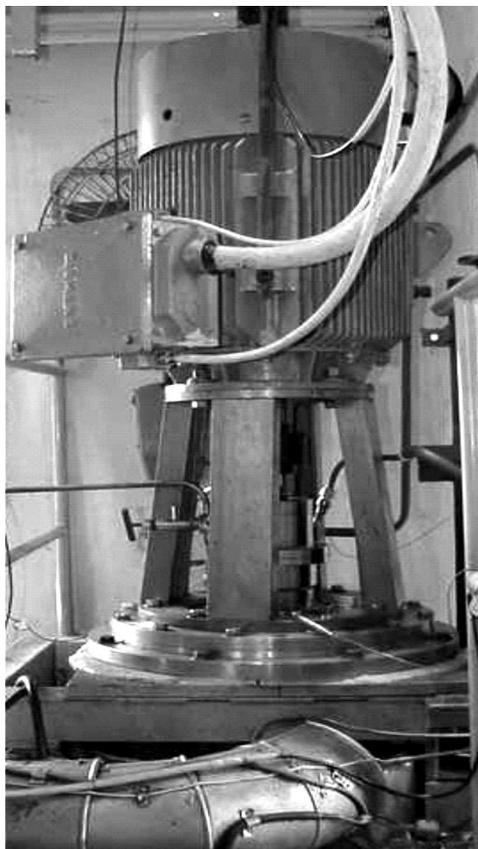
Fig. 1 : Sodium Pump Assembly

mechanical seal at the top and hydrostatic bearing at the bottom. It can deliver 105.5 m³/h at 50 m sodium column at speed of 3100 RPM. The drive is a 37 kW variable speed motor. Considering the pump vibration problems, the speed is limited to 3200 RPM. Figure 1 shows the pump assembly. Vibration measurements were carried out on Motor Drive End, Motor Non-Drive End, Lantern, Pump outer vessel

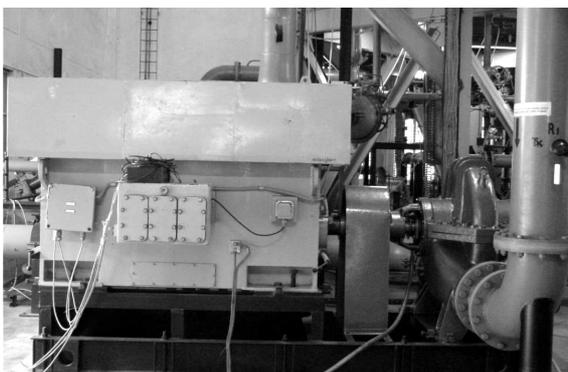
Fig. 6 : 510 kW Pump-Motor Assembly

The ¼ scale model of Prototype Fast Breeder Reactor (PFBR) assembly, named SAMRAT (Scaled Model of Reactor Assembly for Thermal hydraulics), has been designed and commissioned in IGCAR for studying the thermal hydraulics and vibration characteristics of the primary reactor components. A water test loop is used to circulate water through this model for conducting various experiments. Six centrifugal pumps of varying capacities are used for circulating water in the model, for simulating different flow similitude requirements for various experimental studies. One of the large capacity pumps in this loop is of 1200 m³/h flow and 100 m head capacity (Fig.6). This is a single stage horizontally mounted centrifugal pump driven directly by a 510 kW induction motor. The description and features of the pump is highlighted in Table 2.

Vibration measurements were carried out during the pump operation in three axes (horizontal, vertical and axial) on motor and pump at the drive end and non-drive end bearing locations as well as on the foundation pedestal. Development of an abnormality was detected during one such measurement which indicated an increase in overall vibration level from 1.5 mm/s to 5.5 and 6.3 mm/s on pump drive end (DE) bearing locations in horizontal and vertical directions respectively, where as in the non drive end (NDE) location, it was high in vertical direction only (5.9 mm/s). The vibration values observed at other locations were well within the limits (as per the ISO-10816-2 limits for a Class-III machine). So it was decided to monitor the pump operation closely for the next two runs. In the measurements taken subsequently, the pump DE bearing vibration increased to 7.0 and 8.0 mm/s in horizontal and vertical directions

respectively whereas in the pump NDE bearing location, vibration values not varied much. In subsequent runs, the vibration values in both pump DE and NDE bearing locations shot up to 8.4 and 9.2 mm/s. So vibration spectral analysis was carried out to identify the underlying causes for the abnormal pump vibration characteristics.

DE bearing outer race has worn out and the DE gun metal sleeve was having a running hair crack (Fig.8). This transverse crack in the sleeve was causing unbalance in the pump assembly. The unbalance has led to eccentricity in the impeller rotation which is getting reflected as the 5 x RPM component in the spectrum, corresponding to the VPF. As regards the pump DE bearing, the unbalance is causing the bearing to stress out due to uneven loading and resulting in wearing of the outer-race. During the corrective maintenance, the gun metal sleeve and drive end bearing was replaced and pump was re-assembled. Vibration level was also found to be reduced to 1.45 mm/s (Fig.9). Thus vibration analysis was used to detect the abnormality at an earlier stage, otherwise which could have resulted in damage to the shaft and other pump/motor internals.

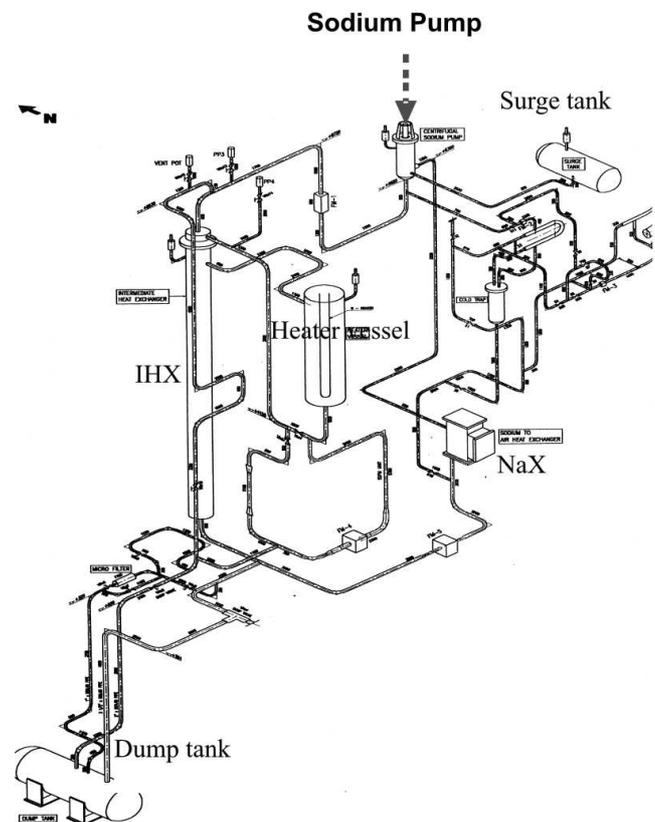
Fig. 10 : 500kW Sodium Loop

A 500 kW Sodium Loop (Fig.10) is designed and constructed in IGCAR to get experience in handling large and high temperature experimental sodium loop and also to test the performance of sodium pumps and other indigenously developed components, designed for various applications in reactors. Sodium is circulated in the loop by a 100 m³/h vertical centrifugal pump, which is installed in the cold leg of the loop. The centrifugal pump takes suction from

Sodium-to-Air heat exchanger (NaX) and forces cold sodium into the tube side of the Intermediate Heat Exchanger (IHX). Being an important component of the 500 kW Sodium Loop, the performance of the sodium pump has to be checked frequently. Hence vibration measurements were carried out on different locations of the pump at periodic intervals. The description and main features of the sodium pump are given in Table 3. The pump has a vertical shaft which is driven by a variable speed DC motor.
