# High Resolution Imagery Collection for Post-Disaster Studies Utilizing Unmanned Aircraft Systems (UAS)

Stuart M. Adams, Marc L. Levitan, and Carol J. Friedland

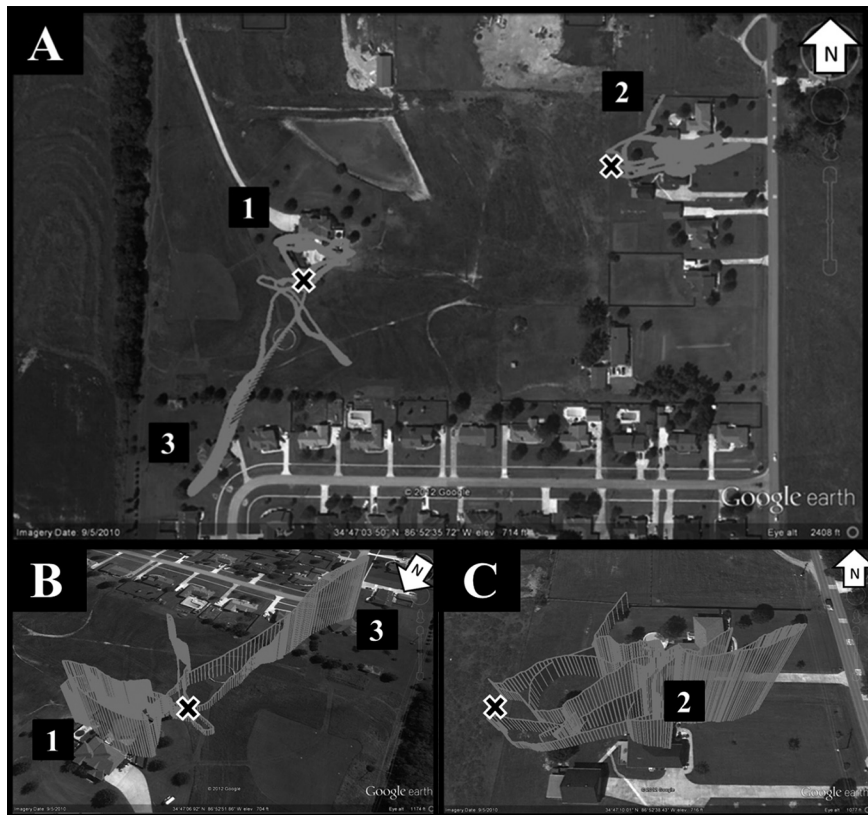
Figure 2. Graphic depicting telemetry data recorded from UAS reconnaissance flights (© Google Earth): (A) Nadir view of flight plan for observing Structures 1 to 3. Isometric views of flight plans for (B) Structures 1 and 3, and (C) Structure 2. Telemetry data including latitude, longitude and altitude above was collected onboard the UAS during flight. Structures 1 and 2 were assessed by multiple UAS passes originating at the locations marked with a black “x.”

For the post-tornado case study, two severely damaged residential buildings were selected as the primary structures to be used in investigating the capabilities of the UAS platform. Figure 2 depicts the flight paths chosen for imagery acquisition. The somewhat erratic nature of the flight paths can be attributed to manual control of the UAV, as semi-autonomous and fully-autonomous flight modes were not pursued due to the high variability and strength of the wind gusts. Flight elevations that enabled the UAV to vertically clear the structures at a comfortable distance, while maintaining operator-to-UAV proximity (preferable in high wind environments) were pursued. Structure 1 was a two-story home with considerable damage to the roof and second story. Ground access to this structure was limited due to a wooden fence (Figure 3A) and the unstable nature of the damaged structure, particularly considering the relatively strong winds occurring at the time of the site visit. The flight path chosen was initiated in an open field nearby and included three ellipsoidal passes of approximately 8 min each at an average flight elevation of 15 m AGL. During the Structure 1 flight, a deviation to investigate a neighboring structure with significant roof damage was made to demonstrate the distance capability of the UAS (Structure

from the UAV-mounted camera as it tracks around the structure (see flight paths from Figure 2) provides a holistic view of the damaged structure and its surroundings. Figure 8A shows a small water body, trees in the distance, and a lack of nearby structures. Figure 8B similarly indicates trees in the distance as well as adjacent homes. Information on the immediate surroundings and the wider neighborhood can be important to understanding the wind loads on a building (i.e., exposure conditions) and the windborne debris environment.

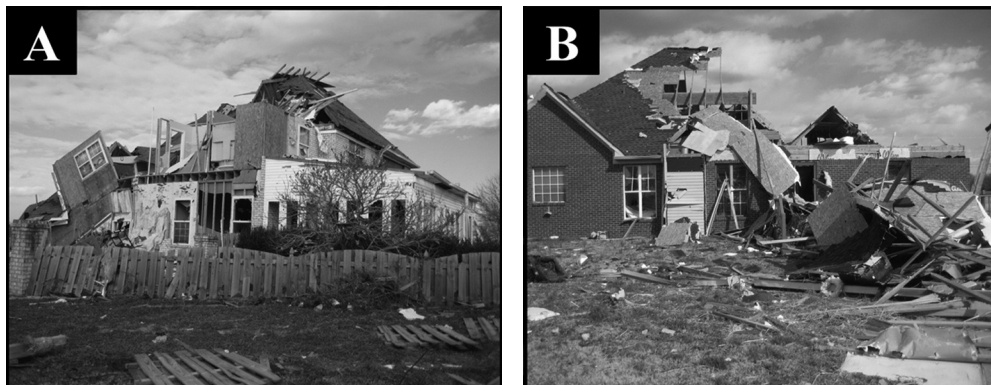
Figure 3. Ground-based imagery of tornado-damaged structures of interest: (A) southwest facing elevation of Structure 1, a heavily damaged two-story home. The fence and unstable nature of the significantly damaged structure prevented close-range ground-based investigation. (B) West facing elevation of Structure 2, a severely damaged one-story structure. The extent of damage beneath the roof line is difficult to quantify based on this ground-based imagery.

3, approximately 200 m from Structure 1). Figure 3B shows Structure 2, a one-story home with considerable roof damage. Numerous passes during the 20 min flight duration were taken to provide imagery from multiple viewpoints at an average flight elevation of 10 m AGL.

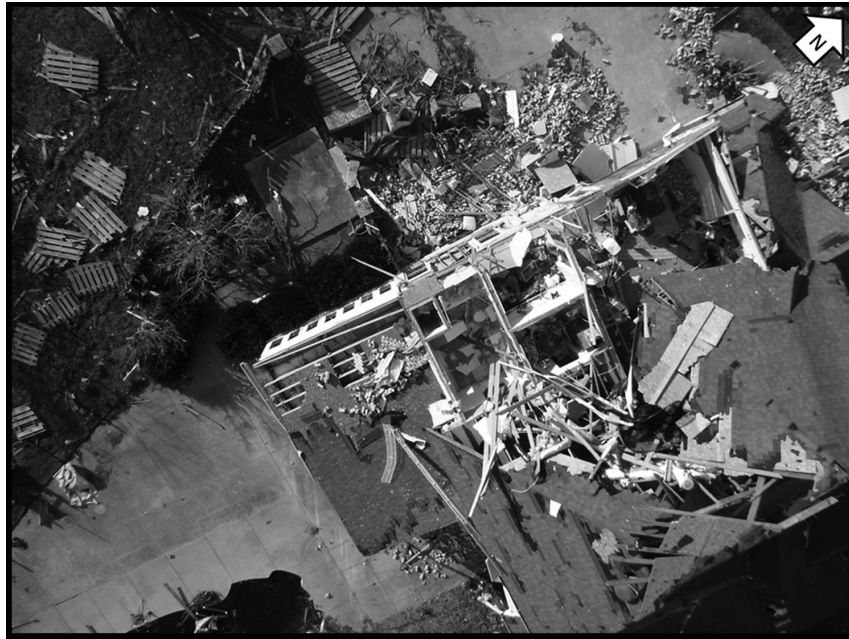
Figure 4. UAV-based still image of Structure 1 taken by the nadir-mounted digital camera, with GSD approximately 0.007 m.

Figures 4, 5, and 6 show a singular image of the house identified as Structure 1, at different zoom levels, collected using the nadir-mounted digital camera on the UAV during the case study. The image was collected at an altitude of approximately 15 m AGL and has a ground sample distance (GSD) of approximately 0.007 m (i.e., distance between centers of adjacent pixels as measured on the ground). Figure 4 clearly shows the debris field surrounding the structure, as well as a severely damaged section of the second-story and roof. A partial floor plan of the structure can be determined as a bedroom, bathroom, and two closets can be identified from this vantage point. Figure 5 provides a zoomed-in image of the top left roof corner of the structure. The construction materials used are easily seen; bricks, sheathing, and roofing materials can clearly be identified. Bathroom roofing materials are absent from the image, indicating a removal of the roof structure as opposed to an inward collapse of the roof. Figure 6 shows an even further zoomed-in view of the same damaged area, demonstrating the very high level of detail obtainable with this UAS. Individual bricks are clearly visible. The remains of red chalk lines on the roof sheathing (used during construction for locating ceiling joists for deck nailing) are visible in areas where the roofing felt and shingles have been removed. The roof decking material on this part of the building can clearly be identified as oriented strand board. The level of detail available in this imagery not only provides in-depth information as to building condition, but can also assist with determination of failure mechanisms and sequences. For example, in Figure 6, the face brick from the second story bathroom wall (in the center right of the picture) fell onto roof sheathing and ceiling joists of the adjacent first story roof, indicating that the first story roof damage occurred first.

building materials, such as the usage of oriented strand board (also called OSB) for roof sheathing, as opposed to plywood (the other commonly used residential roof sheathing material). To put it in a different context, a house with 150 m<sup>2</sup> plan view roof area would be represented by approximately 600 pixels on a NOAA aerial image, versus over 3 million pixels on a UAS image with the setup and flight elevation used for Figure 4.

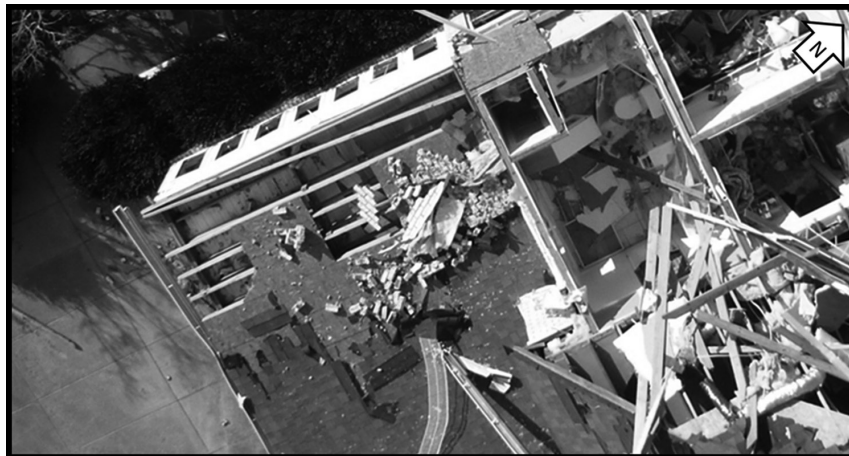
Figure 5. Close-up image of the southwest corner of the Structure 1, which is from the same image file shown in Figure 5, but shown at a higher zoom. While some roof decking has been removed from the edge, ceiling joists are largely intact for the single story exterior corner room in the top left of the image, while the entire roof and ceiling structure has been removed from the adjacent second floor rooms in the top right of the image.

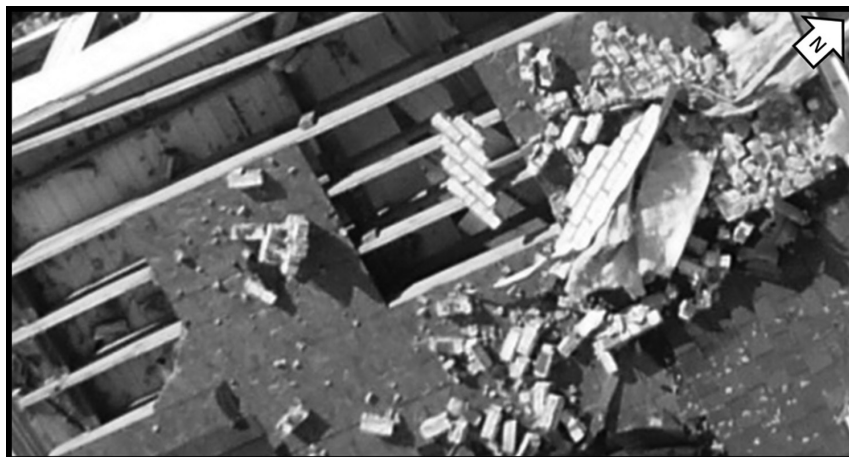
Figure 6. Further close-up of the southwest corner of Structure 1. This image is from the same imagery files shown in Figures 4 and 5 displayed here at an even higher zoom, which demonstrates the full resolution capabilities of the UAV-mounted camera. Construction materials, and damage to the roof covering, roof sheathing, and ceiling beneath the roof joists are clearly visible.

For purposes of comparison, post-disaster National Oceanic and Atmospheric Administration (NOAA) aerial imagery for Hurricane Ike was acquired with an approximate GSD of 0.5 m (NOAA, 2008). Figure 7 (parts A and B) show NOAA aerial images of a residential structure on Galveston. The aerial image seems to show some damage to the roof, although it’s difficult to make out specific details. In contrast, the UAS image shown in Figures 4, 5, and 6 has a GSD of approximately 0.007 m, clearly showing damage and allowing identification of specific

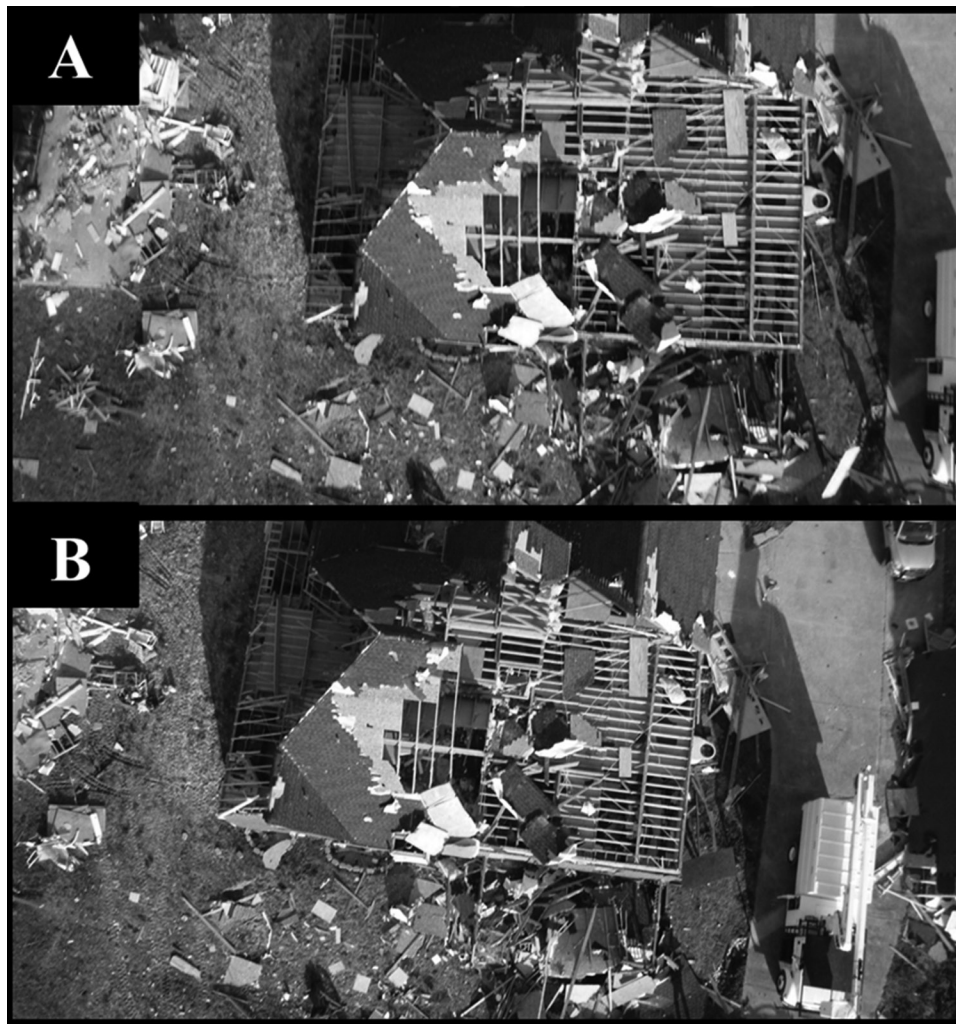
Figure 9. Two overlapping nadir images of Structure 2, potentially useable for stereo-photogrammetric analysis to estimate three-dimensional coordinates of different points on the building.

In addition to the significant opportunities for qualitative image analysis described previously, UAS-based imagery can potentially be used for quantitative analysis as well. Overlapping images such as those shown in Figure 9 can be used for stereo-photogrammetric analysis. The principal of metric photogrammetry states that stereographic photography, specifically photographs with at least a 60 percent overlap of distinguishable objects within each picture, can be used to quantify object parameters (Li *et al.*, 2010). In this case study, the UAS operator was instructed to fly a pattern conducive for such imagery acquisition. However, significant winds during the UAS flights hindered acquisition of images with optimal overlap. Utilizing a pre-defined flight plan as well as an automated flight and/or camera operation could aid in achieving optimal imagery overlaps.
