Safe Right Bundle Branch Block Pattern During Permanent Right Ventricular Pacing

Abstract: It is known that an electrocardiogram (ECG) after transvenous right ventricular (RV) pacing should yield left bundle branch block (LBBB) QRS patterns. When right bundle branch block (RBBB) pacing morphology appears in a patient with a permanent or temporary transvenous RV pacemaker, myocardial perforation or malposition of the pacing lead must be ruled out, even though the patient may be asymptomatic. We report a case of a 77-year-old man who underwent permanent transvenous VDD pacemaker implantation for symptomatic heart block. The postoperative ECG revealed a RBBB pacing configuration, but his chest X-ray and echocardiographic studies confirmed uncomplicated RV pacing. We review and discuss the literature concerning the differential diagnosis of such a safe RBBB ECG pattern. **Key words:** Ventricular pacing, right bundle branch block, pacing lead.

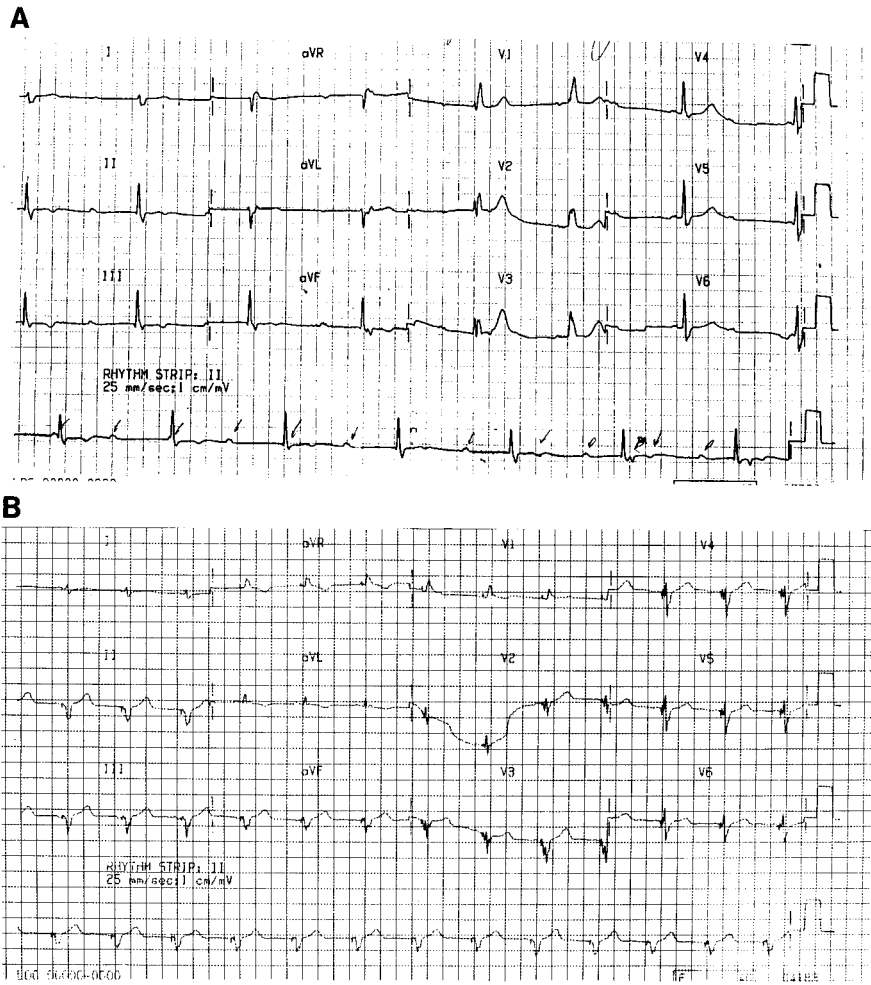
Fig. 1. (A) The initial ECG showed complete heart block with a complete RBBB pattern and an escape rhythm at a rate of 45/min. (B) The postoperative ECG showed an unusual RBBB pattern with RV1 and S1 and a frontal axis around -90° during atrial-tracking ventricular pacing.

taken his own pulse and found it to be below 50 beats per minute); this had prompted him to visit our outpatient clinic. Physical examination was unremarkable except for the presence of Canon A waves over the right internal jugular vein and diminished breathing sounds over both lung fields. The initial electrocardiogram (ECG) showed complete heart block with a complete RBBB pattern and an escape rhythm at a rate of 45/min (Fig. 1A). A transvenous single-pass VDD permanent pacemaker (THERA 8968i, Medtronic, Inc, Minneapolis, MN), using a bipolar lead (CAPSURE VDD-2 5038-58 cm, Medtronic, Inc), was implanted smoothly through the left subclavian vein. The stimulation threshold was 0.2 V at 0.5 ms, the R-wave amplitude was 15.0 mV, the P-wave amplitude was 2.6 mV, and the impedance was 772 ohms. The postoperative course was uneventful and the patient was doing well. However, an unusual RBBB pattern on follow-up ECG with RV1 and S1 and a frontal axis around -90° during ventricular pacing was shown (Fig. 1B). Chest roent-

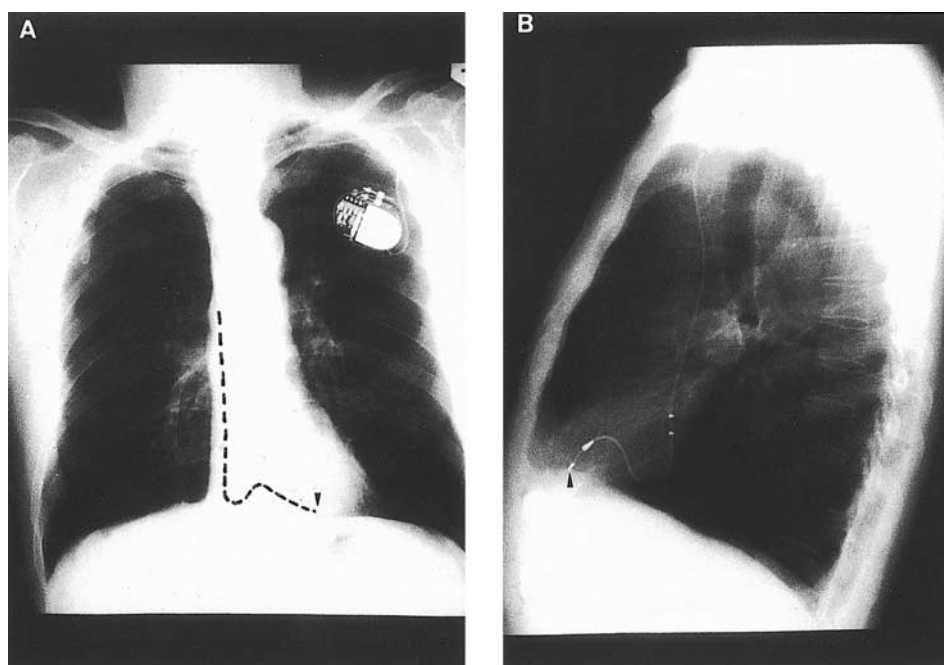
Fig. 2. Chest radiography, including (A) PA and (B) lateral views, demonstrated no RV free wall or septal perforation.

genographic (Figs. 2A and B) studies revealed no RV free wall or septal perforation, and the echocardiogram clearly shows the VDD pacing lead going from the right atrium to the right ventricle (Fig. 3A) and lying in the right ventricular apex (Fig. 3B). The patient had been followed-up for 18 months as of this writing, and there have been no adverse cardiac events.

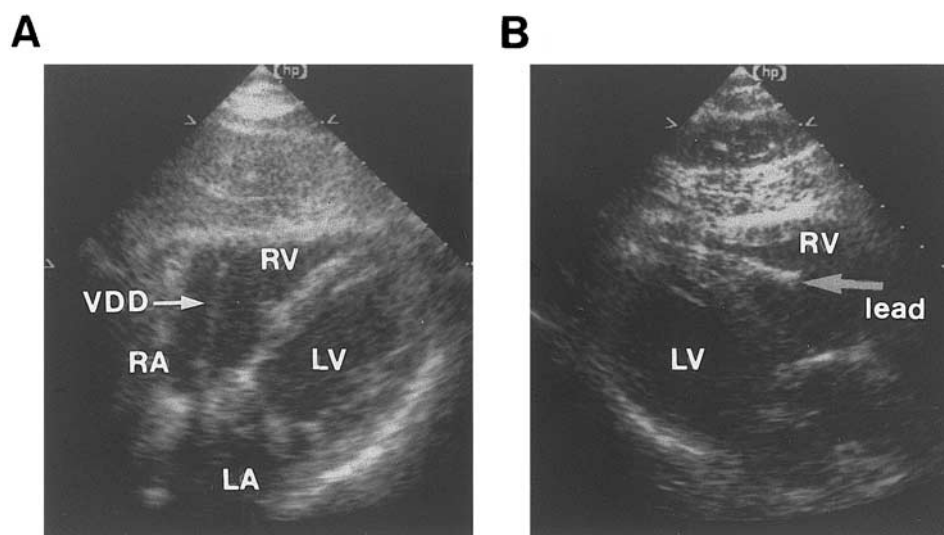
Fig. 3. Echocardiography shows (A) the pacing lead going from the right atrium to the right ventricle in a subcostal four-chamber view, and (B) the tip of the lead lying in the right ventricular apex (parasternal long axis view). RA, right atrium; RV, right ventricle; LA, left atrium; LV, left ventricle.
