# Microstructure Formation and Fracturing Characteristics of Grey Cast Iron Repaired Using Laser

*College of Mechanical and Electronic Engineering, China University of Petroleum, Qingdao 266580, China*

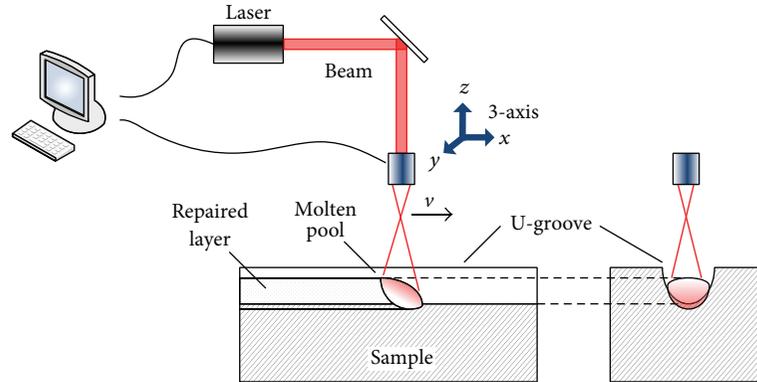
FIGURE 1: Diagram of a laser repairing system.

A diagram of laser repairing experiment system is demonstrated in Figure 1. The impaired substrate surface was removed with a small amount of material to make a U-groove, and then multilayer repairing was conducted to recover the surface morphology and usability. Grey cast iron was processed by DL-HL-T5000 CO<sub>2</sub> laser (laser wavelength 10.6 μm, maximum output power 5 kW) and DL-LPM-IV multifunction NC machine, as shown in Figure 2.

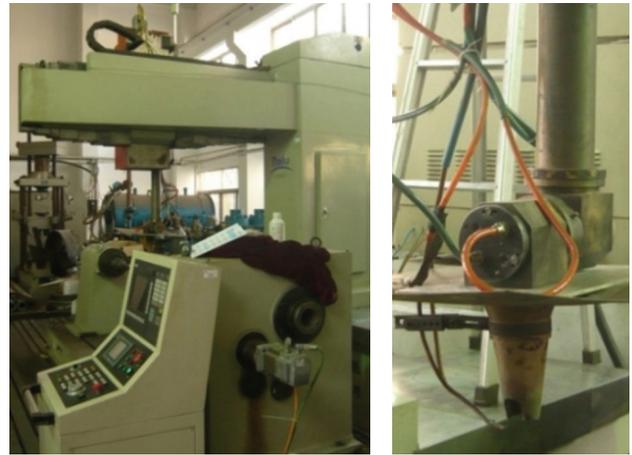
FIGURE 2: Laser repairing equipment.

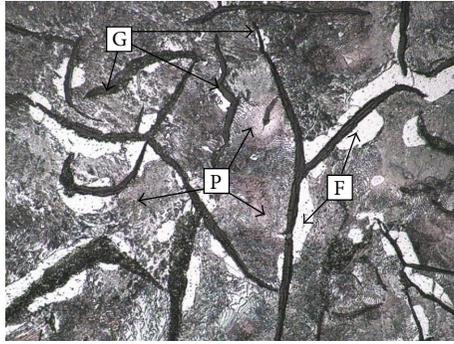
FIGURE 3: Microstructure of HT250 substrate.

Grey cast iron (HT250) is selected as the pending repaired substrate material. The material is made of iron-based high-carbon multielement alloy and its chemical compositions are listed in Table 2. The carbon existence form of HT250 is graphite grain and Fe-C multielement compounds. The cross-section is corroded by 4% Nital and the microstructure is illustrated in Figure 3. The HT250 microstructure consists

of ferrite, pearlite, flake graphite, and a small amount of phosphide eutectic. Sample dimension was about 50 mm × 40 mm × 8 mm. Prior to repair of the grey cast iron surface, the crack was removed. To mimic the operation of crack removal, U-grooves with 3 mm to 4 mm thickness and 4 mm width were fabricated on the sample surface. The samples were ground, polished, and cleaned using absolute alcohol and acetone and then parched.

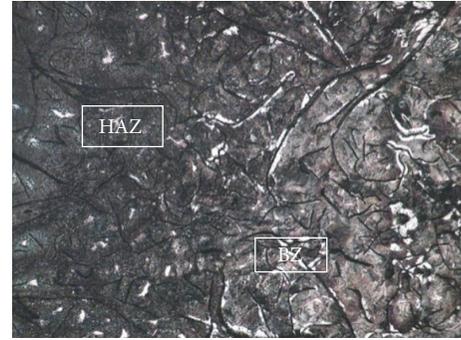
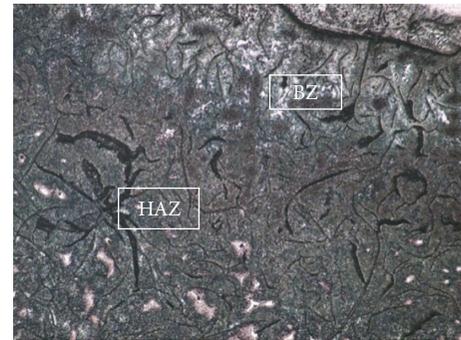
FIGURE 4: Metallographic structure of HAZ × 200: (a) Fe314 and (b) 316L.

**3.1. Heat Affected Zone.** HAZ is located between the BZ and the substrate. The heating temperature of HAZ is between hypoeutectic and eutectoid temperature, and the microstructure only has solid-state phase transition during the repairing process. Figure 4 illustrates the HAZ microstructure under OM. As there is no generation of molten pool in HAZ, this area has little composition attenuation and infiltration with the bond zone. The microstructure morphology of HAZ in the two sets remains the same. Compared with the bond zone and the RZ, the temperature gradient of HAZ is small and the microstructure that contains much unmelted graphite has a mild transition. The primitive microstructure at the bottom of HAZ consists of abundant pearlite and minute quantity of ferrite, whereas the composition of the microstructure at the top of HAZ is rich in ferrite with some needle-like or cryptocrystalline martensite and blocky cementite at eutectoid temperature.

into austenite with some carbon element decomposing into austenite. The transition of pearlite and ferrite is not complete because of the rapid movement of the molten pool. Therefore, HAZ has unbalanced microstructure including unstable austenite, pearlite, ferrite, and graphite. The temperature declines below the eutectoid point with the passage of molten pool. Austenite begins its transition into ferrite and expands relying on graphite. Some austenite cannot be converted completely and turns into residual austenite because of the rapid cooling rate. After exsolution from austenite, the carbon atom is inactive in solid phase and hardly turns into secondary graphite. Therefore, carbon atom combines with neighboring iron atom into secondary high-carbon cementite. As the temperature decreases to room temperature, a complicated microstructure composed of ferrite, martensite, residual austenite, cementite, and graphite is generated, as illustrated in Figure 4.

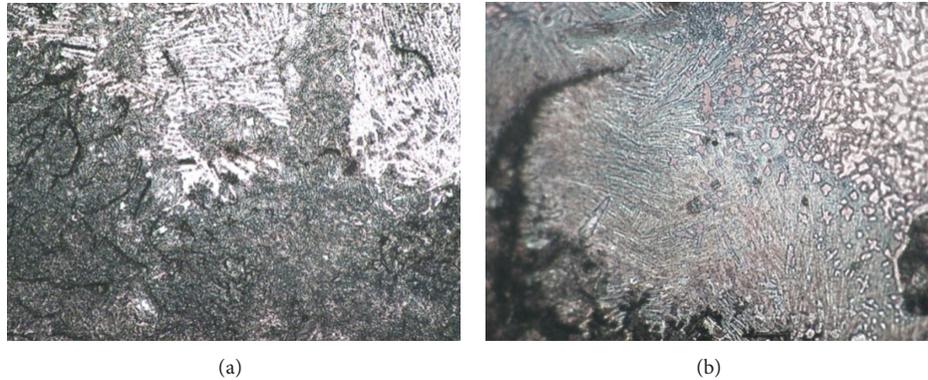
FIGURE 5: Morphologies of BZ  $\times 200$ : (a) Fe314, (b) 316L.

**3.2. Bond Zone.** The BZ is located between HAZ and RZ. The peak temperature at this area can reach above the eutectic point and belongs to micromelting zone at molten pool brink. The microstructure of BZ had obvious transition, as BZ composition had attenuated and infiltrated under the direct effect of molten pool. The supercooling degree of BZ was higher than those of the other areas. In addition, BZ is under the coactions of rapid melting, solidification, and material attenuation. Therefore, a complicated microstructure is created as demonstrated in Figure 5. The composition phases contain ledeburite, needle-like martensite, ferrite, dendritic austenite, and blocky cementite. The complex phases are caused by the existence of carbon. Copious amounts of graphite are dissolved within the BZ and the carbon element cannot be precipitated into graphite because of supercooling. Consequently, carbon element is dissolved into  $\alpha$ -Fe and  $\gamma$ -Fe and generated ferrite and austenite, respectively. Some carbon element has combined reaction with Fe to generate cementite. High cooling rate changes austenite into eutectic ledeburite with cementite. A small number of austenite transform into pearlite and have eutectic reaction with cementite to produce secondary ledeburite. Some unmelted residual graphite is also present. Hence, a complicated multiphase microstructure is generated in BZ.

Austenite in Figure 5(a) keeps high-carbon content during the rapid cooling process. Ni and  $\gamma$ -Fe can produce infinite solid solution, which improves the stability of austenite. However, the hard mechanical mixture, which includes high-carbon martensite and ledeburite, is also generated, because of severe graphite dissolution. The microstructure of 316L in Figure 5(b) is relatively uniform, containing tiny martensite surrounding graphite and some ledeburite, austenite, and cementite at the grain boundaries. It can be seen from the composition of BZ that the microstructure of Fe314 is the mixture of high-carbon martensite and ledeburite, which is more similar with HAZ. However, the microstructure of 316L is mainly tiny needle-like martensite, which is much different from HAZ. Therefore the transitional and bonding function of the Fe314 BZ is much better and obvious than 316L BZ.

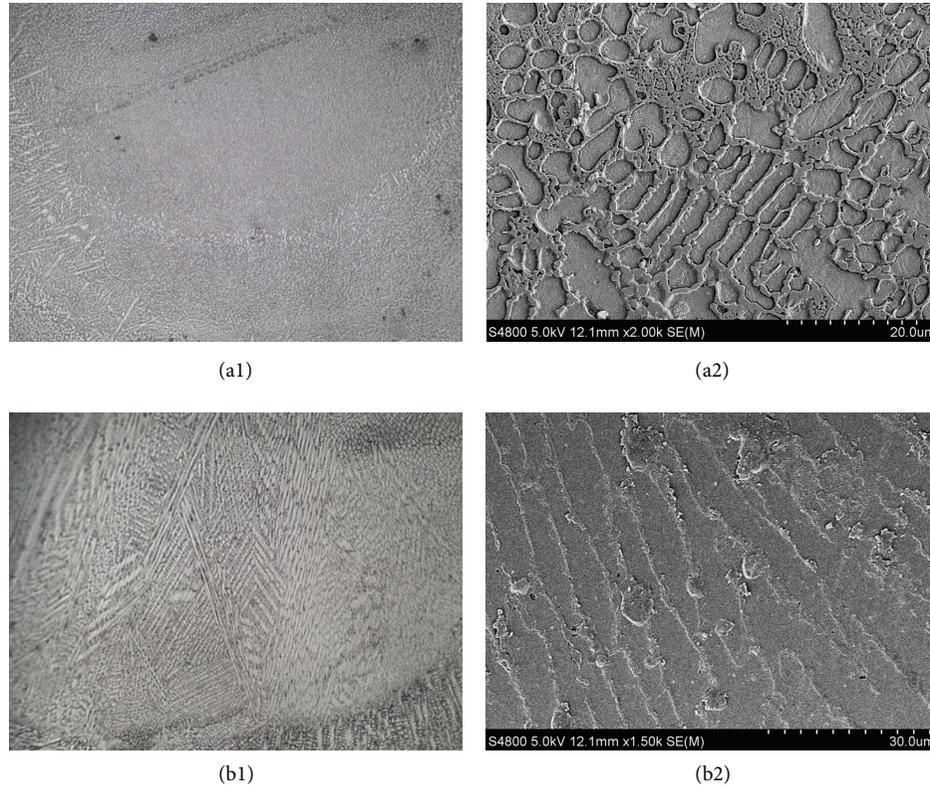
FIGURE 6: Morphologies of RZ: (a1) Fe314: OM  $\times$  100, (a2) Fe314: SEM  $\times$  1500, (b1) 316L: OM  $\times$  100, and (b2) 316L: SEM  $\times$  1500.

With the growth of columnar grain and rapid cooling of molten pool in RZ, the dendrite trunk inherits the growth tendency of the columnar grain in BZ and has obvious extensional growth characteristics [18]. Figures 6(a1) and 6(b1) demonstrate the coarsening of dendrite. However, in the middle of RZ, where increasing degree of supercooling and nucleation rate is observed, the formed columnar grain ceases to develop. Much more new grains begin to accumulate and a fine dendritic microstructure is generated. Grain size and growing direction present a region as a result of nonuniform solute and temperature effect.

Different materials have different grain types. As exhibited in Figure 6(a1), the bonding boundary between RZ and BZ is composed of mainly planar and columnar grains, caused by nucleation, rapid growth, and mutual extrusion. Grains have little branches and turn into isometric grains after transitory growth, as shown in Figure 6(a2). The whole RZ is basically occupied by isometric grain groups, and the coarsening bonding layer only exists at the middle. This observation is mainly produced upon inherited growth of grains, because of microstructure remelts and grain production during second layer repairing.

Comparative microstructure of 316L RZ is a typical austenite stainless steel cellular grain, which is more compact than that of Fe314, as illustrated in Figures 6(b1) and 6(b2). The austenite stainless steel microstructure has large carbon concentration gradient with substrate, which results

in obvious microstructure hierarchy in the solidification and phase transition period of BZ. Therefore, the metallurgical bonding strength of 316L is not as strong as Fe314. The formed grains in the first layer can be the nucleation sites of grains in the second layer, because the composition of the two repaired layers is similar. Thus, liquid metal in the molten pool can keep growing on the foundation of the grains within the former RZ, which presents extensively growing characteristics of inheritance [19].

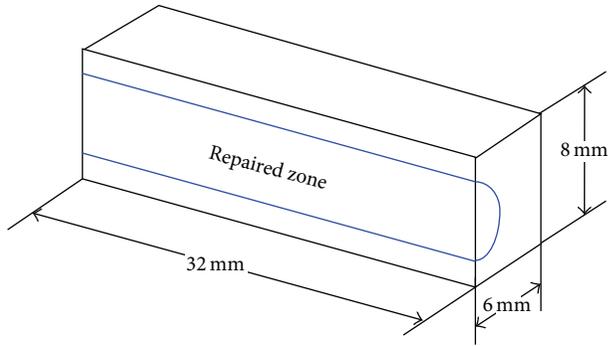
FIGURE 7: Dimensions of bending test sample.

*4.1. Design of Three-Point Bending Test.* To compare with the HT250 substrate without laser treatment, two sets of repaired samples, which have the same repairing process and parameters, were selected for bending test. To fully demonstrate the effect of RZ, the samples of the entire RZ should occupy a certain percentage of the whole volume. The test sample was fabricated using wire electric discharge machine, as exhibited in Figure 7.

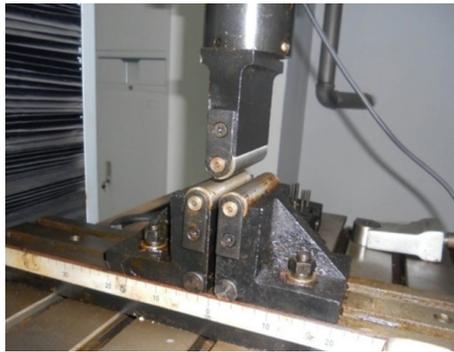
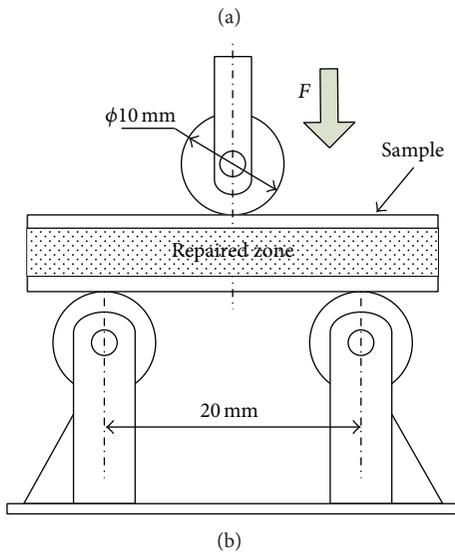
FIGURE 8: Three-point bending test: (a) testing machine, (b) loading sketch.

The WDW-100D testing machine was used in the bending test. The maximum loading force was 100 kN, with an accuracy grade of 0.5. Figure 8 schematically depicts the test equipment and the sketch of the sample position.

The span of the two supporting points is 20 mm and the surface of RZ is toward the outside direction. The diameter of top indenter is 10 mm. The substrate and repaired samples are placed on the bottom indenter of the testing machine and suffer the steady load from top indenter. The load and displacement data of different samples in fracturing process are extracted and drawn into the load-displacement curves.

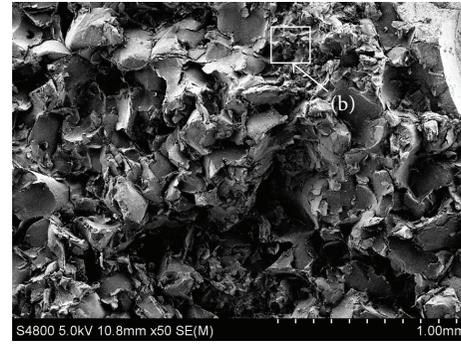
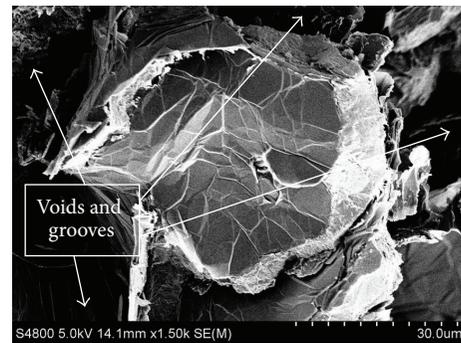
FIGURE 9: Fracture appearances of HT250 sample: (a) macroappearance SEM  $\times 50$ , (b) SEM  $\times 1500$ .

**4.2. Fracture Appearances Analysis.** The HT250 substrate fracture appearance is shown in Figure 9(a). The macrofracture mainly contains serration and lamellar fragments. The large cleavage plane is flat and glossy, which belongs to brittle fracture, whereas the small cleavage plane is partly accompanied with lacerated fragments. Considering the plasticity of

pearlite and ferrite, part of the appearance presents characteristics of ductile fracture. In addition, the cleavage cracks mainly propagate along thick flaky graphite. Thus, plenty of voids and grooves which are caused by the peeling graphite are found around the fractured substrate, as exhibited in Figure 9(b). The macrobrittle fracture of HT250 substrate contains microductile fracture behavior.

as illustrated in Figure 9. With the process of bending test, the flaky graphite along the cracking direction then turns into a crack propagation path, in which the substrate is torn quickly. As the crack propagates closer to the RZ, the graphite amount in BZ declines rapidly, and the microstructure is

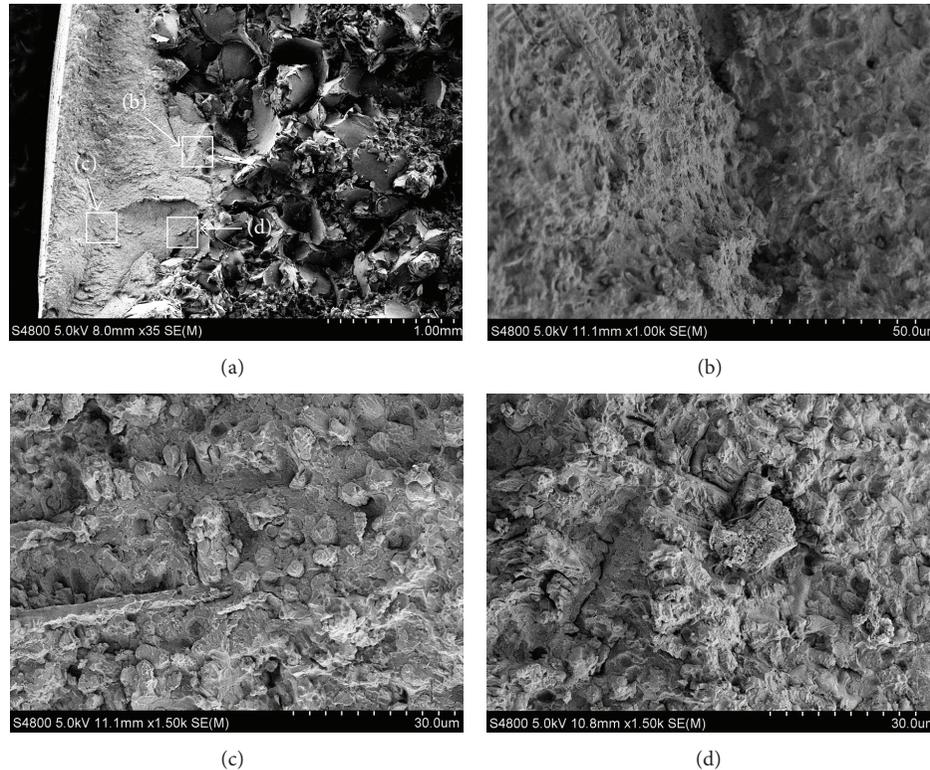
FIGURE 10: Fracture appearances of Fe314 sample: (a) macroappearance SEM  $\times 35$ , (b) BZ SEM  $\times 1000$ , (c) RZ SEM  $\times 1500$ , and (d) BZ SEM  $\times 1500$ .

The macro- and microfracture morphologies of the RZ in the bending samples of Fe314 and 316L are shown in Figures 10 and 11, respectively. In the vertical direction of laser scanning, the characteristics of the transverse fracture of the RZ and the substrate are completely different. A transition in the bond zone is observed and no obvious delamination is found between the RZ and the substrate, which indicates that the bonding is tight and the fracture consistency is excellent. Part of the macrofracture surface of Fe314 RZ is flat, as shown in Figure 10(a). Fibrous zone and radial fragments can be observed and the cracks propagate along the divergence direction. A large amount of independent cracks interconnect and propagate to produce the fracture, which exhibits the characteristics of ductile fracture.

To investigate the fracture mechanism at different positions, two positions in BZ and RZ are observed with high magnification, respectively, as shown in Figures 10(c) and 10(d). Both fractures are of typical intergranular dimple morphologies. Various columnar and cellular grains are torn and obvious dimple interspace is produced. The microstructure analysis indicates that a small amount of graphite precipitated

flaky hard martensite, and lower bainite remains in this area. Deep grooves are induced by the separation of graphite from the fracture. Characteristics of intergranular fracturing are evident in micromorphological analysis. By comparing the dimple morphologies, grains in Figure 10(c) are more tiny and littered than that in Figure 10(d). BZ is located in the remelting area between the double repaired layers, and the grains are coarse and directional, consistent with the microstructure analysis. Therefore, the intergranular dimple fracturing of the microarea is between the ductile and brittle fracturing characteristics, and the macroarea presents mixed fracturing mechanism of ductile and brittle fracturing.

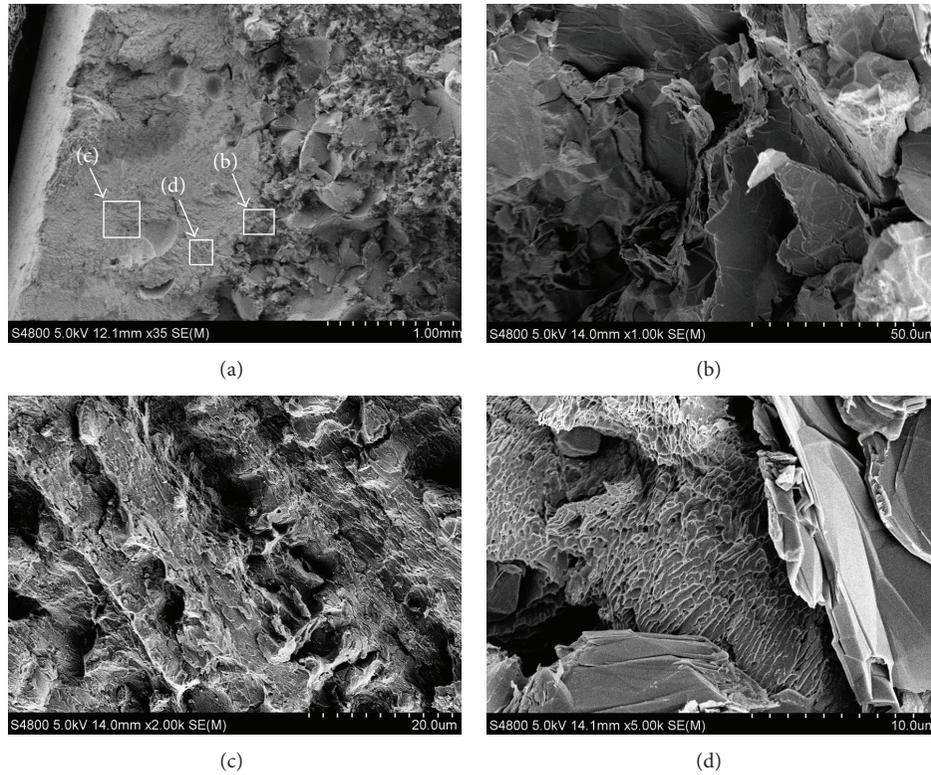
FIGURE 11: Fracture appearances of 316L sample: (a) macroappearance SEM  $\times 35$ , (b) BZ SEM  $\times 1000$ , (c) RZ SEM  $\times 2000$ , and (d) BZ SEM  $\times 2000$ .

The appearance of the 316L repaired sample fracture is shown in Figure 11. Fracture microstructure of RZ is more compact (Figure 11(a)). The radial fragments of the fracture are not clear and shear lips are observed. The magnification of bond zone in Figure 11(b) illustrates that there is a transition from quasicleavage brittle fracture to ductile fracture from substrate to RZ. Figure 11(d) is a higher magnification of bond zone morphology, which shows that the fracturing characteristics of diverse parts have evident difference. The right side has a lamellar brittle fracture, whereas the left side is composed of tiny dimple ductile fracture. The micro-morphology in RZ shown in Figure 11(c) illustrates a similar intergranular fracture condition with Fe314. However, as the RZ of 316L is austenite stainless steel, microstructure is more compact and precipitation from grain boundary is barely visible. Therefore, this area has good toughness. The tear

mark is more obvious at the grain boundaries. Intergranular dimples are deep, and the strengthening effect of grain reticular structure is better. Meanwhile, fracture toughness is closely related to microstructure. The amount of grain boundary increases with grain refinement. Consequently, fracturing paths increase and the crack propagation energy is weakened. Thus, the preventive effect of grain boundary on crack propagation increases and costs more energy to propagate across the grain boundaries.

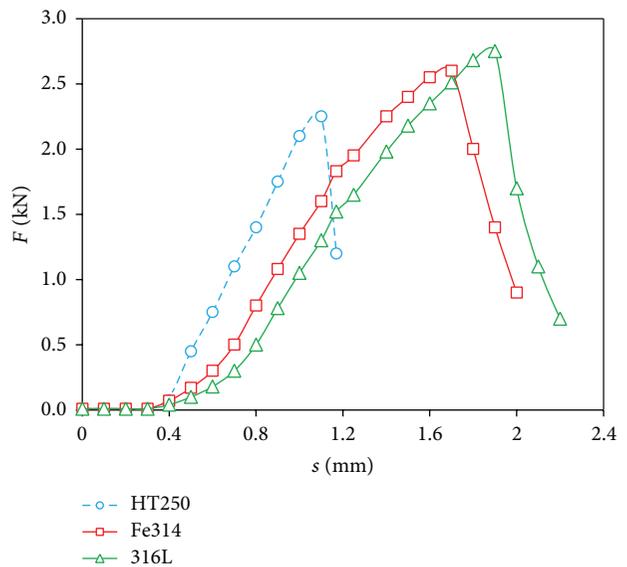
FIGURE 12: Load-displacement curve.

The load ( $F$ ) and displacement ( $s$ ) curve of fracturing process is illustrated in Figure 12. For the substrate HT250, the load reaches 2.23 kN and then the sample fractures suddenly. The tendency of the  $F$ - $s$  curve is like a straight line, which indicates that the fracture is typical brittle fracture. The crack propagates quickly under large stress and the load declines rapidly from 2.23 kN to 0 kN. For the repaired samples, the displacement under the same load is larger, which proves that the toughness is increased. The peak values of the load of Fe314 and 316L sample are 2.6 kN and 2.75 kN, respectively, which are both higher than that of substrate. This is because the microstructure of RZ is compact and refined, which mainly includes austenite, pearlite, and residual austenite. Besides, there is little flaky graphite in RZ. These contribute the higher tensile strength of repaired samples. The crack is restrained when it propagates to the boundary of RZ and then

followed by a slow propagation. As shown in Figure 12, there is a transitory yield procedure around the peak load. When the load is beyond the yield strength, the crack propagates across RZ, and the repaired samples fracture eventually.

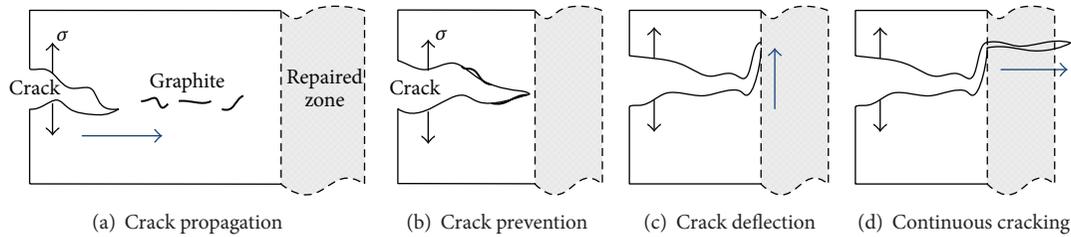
FIGURE 13: Cracking model of repaired layer.

**4.4. Crack Prevention Behavior of the RZ.** The main crack remains vertical with maximum tensile stress direction when cast iron substrate fractures. More branches appear at the sides of the main crack and interconnect gradually within the graphite cavity. From the analysis of the fracturing characteristics of samples, laser RZ has positive effect on the fracture prevention when sample is under impact of external concentrated stress. A cracking model is established to depict the fracturing process of the bending test, which is similar to the model for crack propagation process, which is stated in [13]. The cracking model is illustrated in Figure 13 and the arrows present the crack propagation direction.

Crack propagation (Figure 13(a)) is initiated under effect of steady tensile stress at the boundary within one side of sample *i*. The strength of flaky graphite in grey cast iron is extremely low and flaky graphite acts as cavities in substrate. The sharp corners of flaky graphite can cause stress concentration easily, which promote the crack propagation. Therefore, the initiated crack propagates along graphite and substrate between the closest graphite under the external bending stress [13]. This can be verified by the fracture morphology of HT250 substrate in the three-point bending test. The cleavage crack propagates along the thick flaky graphite,

more compact, as shown in Figure 13(b). The lack of graphite cut off the propagation routine of crack and the compact RZ microstructure with better strength and hardness makes the crack propagation much difficult [13]. With the effect of steady tensile stress, the crack propagation energy accumulates at the tip of crack, which induces the crack wider [21]. Crack propagation along the original direction suffers more resistance, and propagation direction changes from transverse to longitudinal direction. New stress concentration point needs to be found for the crack propagation as exhibited in Figure 13(c). When the crack encounters local abundant graphite or existing microcracks and when the accumulated crack energy reaches a high value, a crack source is generated at the tension side of the RZ. Consequently, the stress concentrates again, and the crack direction reverts to transverse direction as shown in Figure 13(d). To some extent, the RZ has plasticity resistance of tensile stress; the maximum force is a little higher than the substrate without laser repairing. Finally, the crack propagates rapidly in the RZ and leads to sample fracture.

From the analysis of cracking model of the RZ, the characteristic effect of laser RZ is the deflection of cracking direction. Moreover, the effect is clearer when cracking direction is vertical with laser scanning direction. The deflection of crack direction presents the effective function of the material at this area to prevent cracks. Compared with linear cracking, the frequent change of cracking direction prolongs the propagation path and requires more energy to keep the cracking state. Intensity factor of effective stress at crack front end and crack propagation rate declines with decreasing effective stress of cracking. Therefore, the repaired sample exhibits characteristics of good cracking prevention.
