# The Corrosion Behavior of AZ91D Magnesium Alloy in Simulated Haze Aqueous Solution

**Abstract:** The corrosion process of AZ91D magnesium alloy in simulated haze aqueous solution has been studied by electrochemical measurements, immersion tests and morphology characterization. Results show that AZ91D was corroded heavily in simulated haze aqueous solution due to the loose and breakable product film on the surface providing little corrosion barrier. The effect of different ions was investigated. It was found that both  $\text{NO}_3^-$  and  $\text{NH}_4^+$  played an important role in the corrosion process.  $\text{NO}_3^-$  helped to form passive film to protect the matrix, yet  $\text{NH}_4^+$  consumed  $\text{OH}^-$ , resulting in the absence of  $\text{Mg}(\text{OH})_2$  and serious corrosion. Meanwhile,  $\text{SO}_4^{2-}$  and  $\text{Cl}^-$  had influence on pitting corrosion. Magnesium aluminum oxide and  $\text{MgAl}_2(\text{SO}_4)_4 \cdot 22\text{H}_2\text{O}$  instead of  $\text{Mg}(\text{OH})_2$  were the dominate products, which is different from the former study. Corrosion rate changed with time, especially in the first 3 h. A two-stage corrosion mechanism is propo

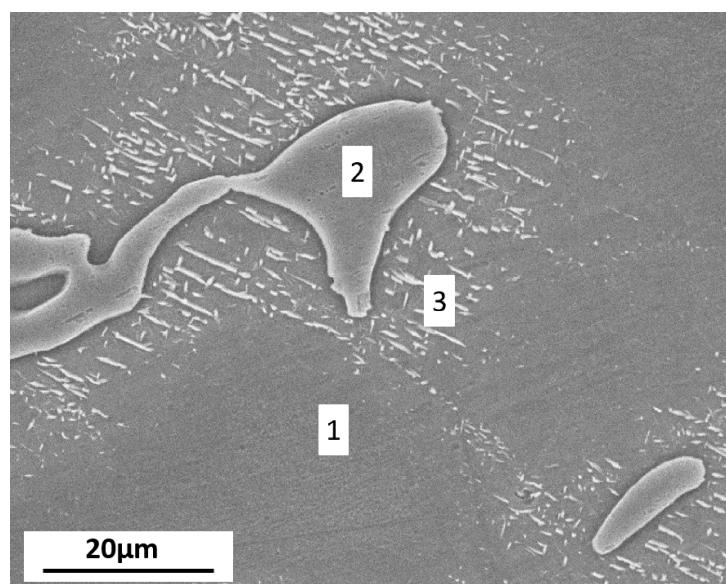
In Figure 1, the microstructure of AZ91D alloy is presented. It shows that AZ91D is a two-phase alloy, consisting of  $\alpha$ -matrix (marked (1) in Figure 1) and  $\beta$ -phase (marked (2) in Figure 1). The fine lamellar ( $\alpha + \beta$ ) micro-constituents are marked (3) in Figure 1, with white regions representing  $\beta$ -phase. The large  $\beta$  articles are interconnected and form a fine network throughout the microstructure. Further, the element composition of regions 1 and 2 measured by EDX is presented in Table 2.

**Figure 1.** The microstructure of AZ91D.

**Table 2.** The element composition of regions 1 and 2 in Figure 1 (in wt.%).

Region	Mg	Al	Zn
1	97.72	1.56	—
2	70.21	27.25	1.86

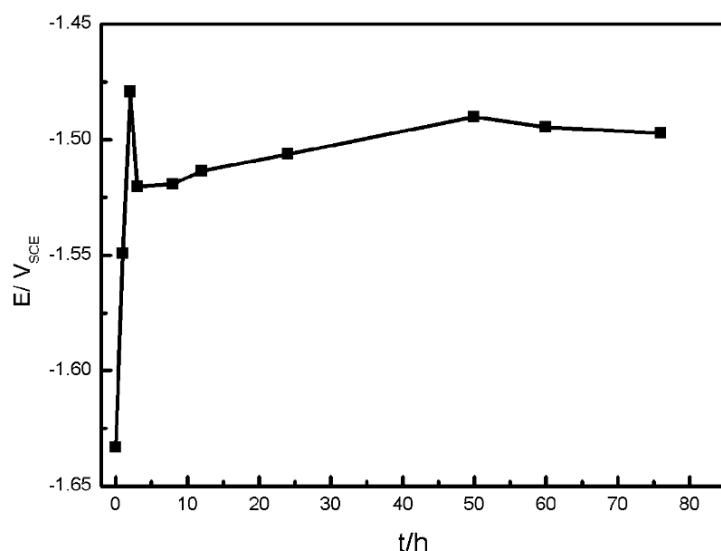
The variation of OCP during the immersion time presents the chemical stability of working electrode, through which we can infer the corrosion process of samples. Figure 2 presents the OCP during immersion tests in simulated HA solution for 76 h.

As shown in Figure 2, the OCP of AZ91D is affected by immersion time, especially in the first three hours. The original potential is  $-1.63$  V and after the sample is immersed in simulated HA solution for 3 h, the OCP approaches to  $-1.48$  V, raised by  $0.15$  V, suggesting the formation of slightly protective corrosion film on the surface. However, the OCP drops suddenly after 3 h immersion, and then increases slowly as the immersion time increased, which is likely due to the breakage of protective film and the development of pitting.

**Figure 2.** OCP dependence on immersion time of AZ91D in simulated HA solution.

As described earlier, the corrosion rate of AZ91D immersed in simulated HA solution changed with time. Figures 2, 3 and 6 indicate that the corrosion process firstly suppressed then accelerated and finally reached stable. The corrosion resistance reached peak value after about 3 h immersion due to the formation of passive film on the  $\alpha$ -matrix surface.  $\text{NO}_3^-$  played an important role in the process, according to Figures 11c and 13b. In the meantime, the  $\text{Cl}^-$  preferentially attacked the weak sites of surface film to form the active sites [38]. Then the localized corrosion initiated at the active sites, as depicted in Figure 9a.

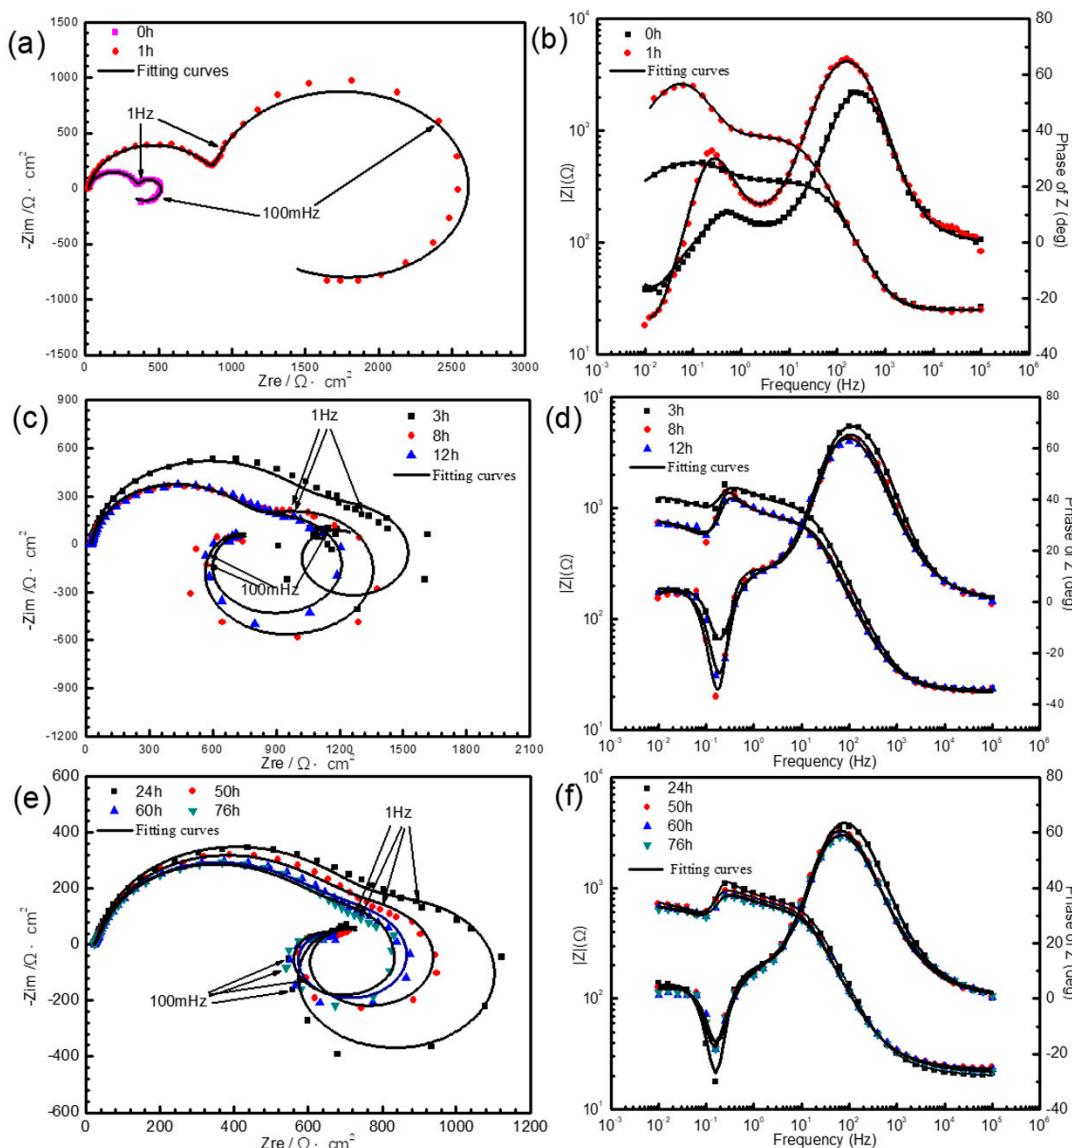
After immersion in simulated HA solution for various times up to 76 h, Nyquist and Bode diagrams of AZ91D sample are depicted in Figure 3, exhibiting various electrochemical characteristics.

As can be seen from Figure 3a, when the immersion time is less than 3 h, the Nyquist plots are characterized by two well-defined capacitive loops: one capacitive loop is at high frequencies and the other is at medium frequencies. In addition, there is also an inductive loop at low frequencies. Both the high frequencies and medium frequencies capacitive loop increase over the immersion time. In the meantime, the medium frequencies loop grows much faster than the high frequencies one.

As shown in Figure 3c,e, when the immersion time reaches 3 h, the fourth constant time is emerged: a new capacitive loop in the low frequencies range. Meanwhile, the medium frequencies capacitive loop decreases evidently. With the further increase of immersion time, the high frequencies and medium frequencies capacitive loop and medium frequencies inductive loop all degenerate, while the low frequencies capacitive loop changes a little.

These results are similar to those reported by Chen [30] et al. It has been suggested that the high frequencies capacitive loop is attributed to the charge transfer resistance and double capacitance at the metal/solution interface. They proposed that the capacitive loop in the medium frequencies

range is induced by film effect in the corrosion process, which referred to the formation of  $\text{Mg}(\text{OH})_2$  and  $\text{MgAl}_2(\text{OH})_8 \cdot \text{H}_2\text{O}$ , meanwhile the capacitive loop in the low frequencies range could be attribute to localized corrosion and the formation of  $\text{MgAl}_2(\text{SO}_4)_4$ . However, in this study  $\text{Mg}(\text{OH})_2$  and  $\text{MgAl}_2(\text{OH})_8 \cdot \text{H}_2\text{O}$  could not be detected due to  $\text{NH}_4^+$ , which will be described below, so we speculate that the film effect resulting in capacitive loop in the medium frequencies range may refer to the formation of  $\text{MgO}$ , one of the main products in this article. The low frequencies inductive loop is produced by the metastable  $\text{Mg}^+$  concentration [30,31].

**Figure 3.** EIS dependence on immersion time of AZ91D in simulated HA solution: (a,c,e) Nyquist (b,d,f) Bode.

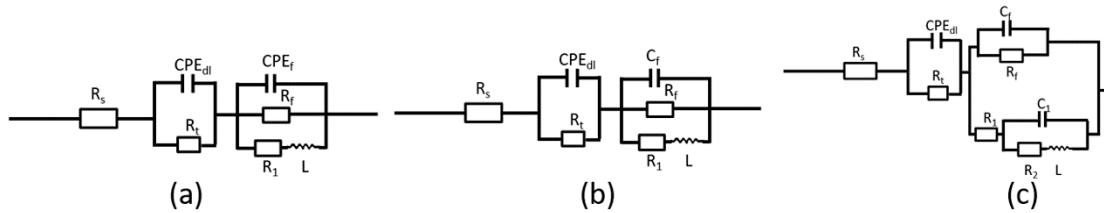
In order to better understand the electrochemical processes of the AZ91D in the HA environment, the equivalent circuits were introduced as shown in Figure 4. When the sample was just immersed in the simulated HA solution, the equivalent circuit could be attained (Model A): a solution resistance  $R_s$ , a charge transfer resistance  $R_t$ , in parallel with the double layer constant phase element  $\text{CPE}_{\text{dl}}$ , film resistance  $R_f$ , in parallel with film constant phase element  $\text{CPE}_f$ , and the inductance  $L$  induced by metastable  $\text{Mg}^+$  ions in series with a charge transfer resistance  $R_1$ ; When the immersion time was 1 h, the equivalent circuit could be obtained (Model B):  $\text{CPE}_f$  is altered to  $C_f$ , indicating the film effect

became relatively stable; when the immersion time was more than 3 h, the equivalent circuit could also be obtained (Model C):  $C_1$  is assigned to the layer where localized corrosion occurred, and  $R_2$  is the  $MgAl_2(SO_4)_4$  film resistance, and the other parameters are consistent with those in Model B. It can be seen from Figure 3 that the equivalent circuits fit the experimental data well, implying that equivalent circuits in Figure 4 are suitable.

**Figure 4.** Equivalent circuits for AZ91D with different exposure time in simulated HA solution: (a) Model A, (b) Model B, (c) Model C.

Figure 12 shows the Nyquist diagrams of AZ91D samples immersed in solutions containing different concentrations of water-soluble ions, exhibiting various electrochemical characteristics. The equivalent circuit is Model A in Figure 4a. The shape of the complex diagram changes with ions concentration and displays how the ions influenced the corrosion process. Figure 12a indicates that  $\text{SO}_4^{2-}$  is harmful to AZ91D, but the impedance arcs reach a stable state once the concentration of  $\text{SO}_4^{2-}$  exceeds a certain value. Figure 12b reveals that  $\text{NO}_3^-$  is a kind of protective ions, as the impedance modulus value tends to grow large with the increasing concentration. Figure 12c shows that  $\text{NH}_4^+$  is the most significant ion in this study, for the impedance modulus value decreases by more than four times with only 0.01M  $\text{NH}_4^+$ . Figure 12d suggests that  $\text{Cl}^-$  does not show evident influence. Therefore,  $\text{NO}_3^-$  and  $\text{NH}_4^+$  are the two most obvious ions among the four kinds of water-soluble ions.

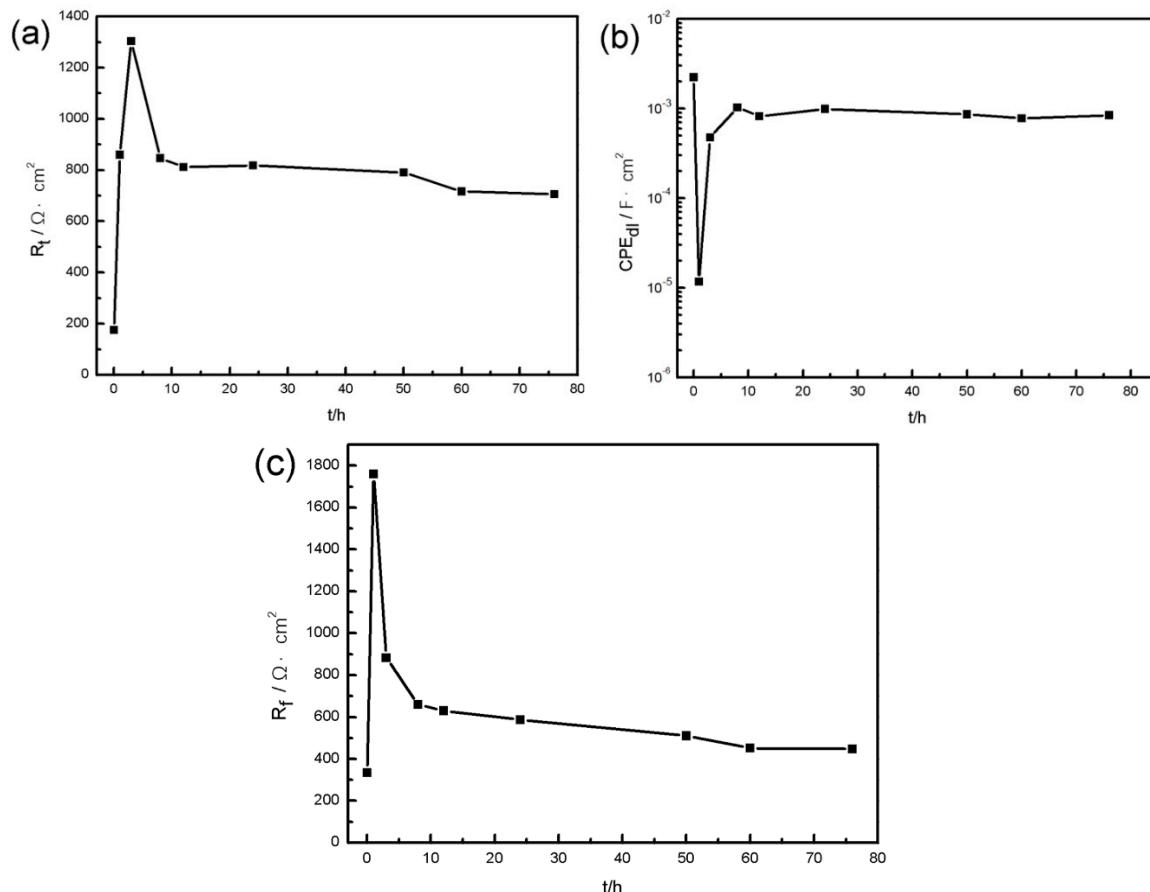
Figure 5 shows the EIS fitting results including  $R_t$  (Figure 5a),  $CPE_{dl}$  (Figure 5b), and  $R_f$  (Figure 5c). It can be found that  $R_t$  of the specimen first increases with immersion time, but after immersion for 3 h, the value of  $R_t$  begins to decrease and maintains a lower level, simultaneously,  $R_f$  shows the same variation tendency. However,  $CPE_{dl}$  represents an opposite performance. It indicates that an effective barrier appeared during the initial stage of corrosion, then the protective film was broken and localized corrosion developed, coinciding with the OCP result.

**Figure 5.** Fitting results of resistances and constant phase element during the immersion test: (a) charge transfer resistance  $R_t$ , (b) constant phase element  $CPE_{dl}$ , (c) film resistance  $R_f$ .

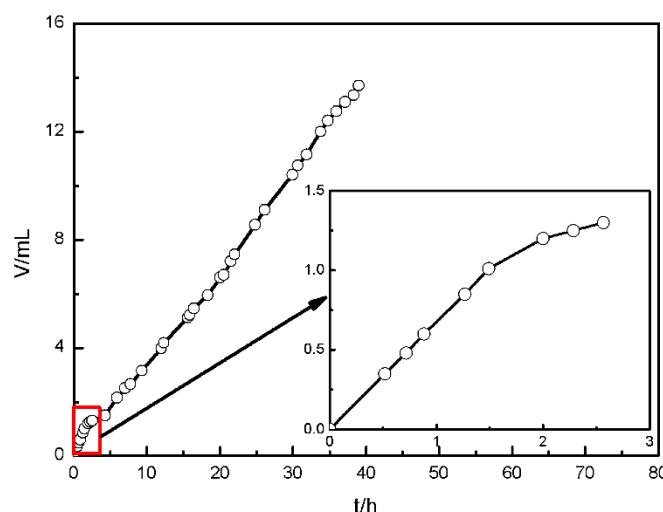
The corrosion rate of sample can be evaluated by the volume of the hydrogen collected in situ [32]. Figure 6 shows the volume of hydrogen generated by AZ91D immersed in simulated solution. In the first 1.5 h, the volume of hydrogen has a rapid growth, suggesting that the corrosion rate was fast. During 1.5–2.5 h, the volume increases slowly, indicating that the corrosion rate slowed down. After that, the volume of hydrogen extends a certain value per unit time, implying that the corrosion rate kept stable. This is in good agreement with the results obtained from OCP and EIS measurements.

**Figure 6.** Volume of hydrogen evolution of AZ91D in simulated HA solution.

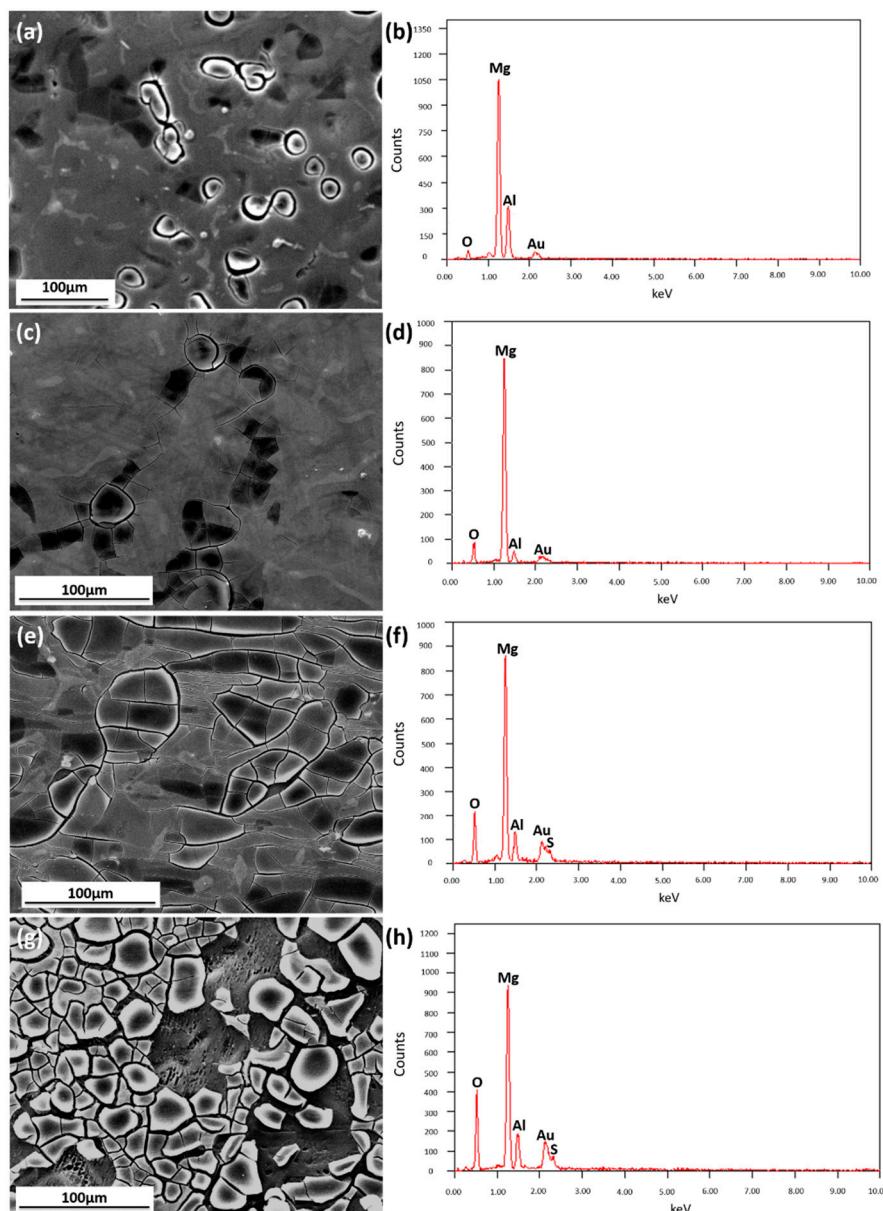
Figure 7 displays the SEM surface morphology and the corresponding EDX of AZ91D immersed in simulated HA solution for 1.5, 3, 8 and 48 h. In Figure 7a, there is a few small pitting points, and the surface is almost flat, even  $\beta$ -phase can be recognized on the surface. Figure 7b indicates a low O/Mg ratio. As time increases, small pitting points grow up and product film forms on the surface. Figure 7c shows that the product film ruptures and localized corrosion begins to deteriorate, and the signal ratio of O/Mg increases. After 8 h of immersion, the surface is seriously damaged (Figure 7e), and the signal peak of S appears evidently (Figure 7f). Figure 7g suggests that AZ91D surface is terribly damaged after being immersed for 48 h. The EDX measurement shows that the signal ratio of O/Mg increases over time, and Al content is almost unchanged. That is likely because the grains have corroded away, leaving a fine network structure consisting of higher aluminum content.

**Figure 7.** SEM (a,c,e,g) images and EDX results of samples immersed in solution for 1.5 h (a,b), 3 h (c,d), 8 h (e,f) and 48 h (g,h).

Figure 8 shows the cross-section of corrosion layer formed on AZ91D alloy after immersion for 48 h. It reveals a discontinuous and cracked corrosion film of about 10  $\mu\text{m}$ , and O enrichment is found in the corrosion layer, meanwhile Al has nearly the same content between the bulk material and corrosion layer, which is in good agreement with Figure 7.

When the immersion time exceeded 3 h, the corrosion rate increased. As can be seen from Figure 7c, the tiny cracks undermined the alloy matrix, and bare Mg was exposed to the solution, causing the reduction of corrosion resistance. When the cracks were so large that the surface could not hold corrosion product, part of the film began to slip. Therefore, barer matrix was exposed and corrosion became serious. According to the mechanism proposed by Chen [30], the aluminum concentration in the solution increased due to the dissolution of the eutectics ( $\alpha\text{-Mg} + \beta\text{-Mg}_{17}\text{Al}_{12}$ ), once aluminum concentration achieved a certain value, the precipitation of  $\text{MgAl}_2(\text{SO}_4)_4 \cdot 22\text{H}_2\text{O}$  was formed as reaction (2), which occurred mainly in the pitting area. Figure 11b suggests that the corrosion pits still existed, but they were much more alleviative when  $\text{SO}_4^{2-}$  was absent in the solution. This indicates that  $\text{Cl}^-$  gave rise to the localized corrosion and  $\text{SO}_4^{2-}$  aggravated corrosion pits.

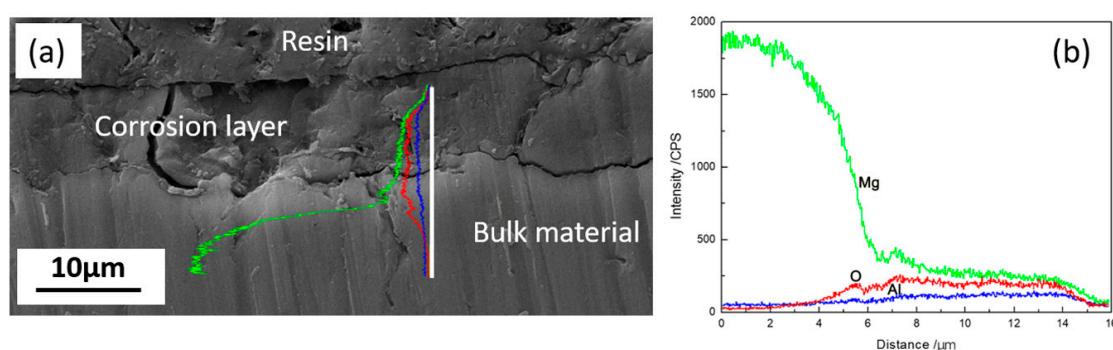
**Figure 8.** The cross-section of sample immersed in HA solution for 48 h (a) and the corresponding linear EDX spectra (b).

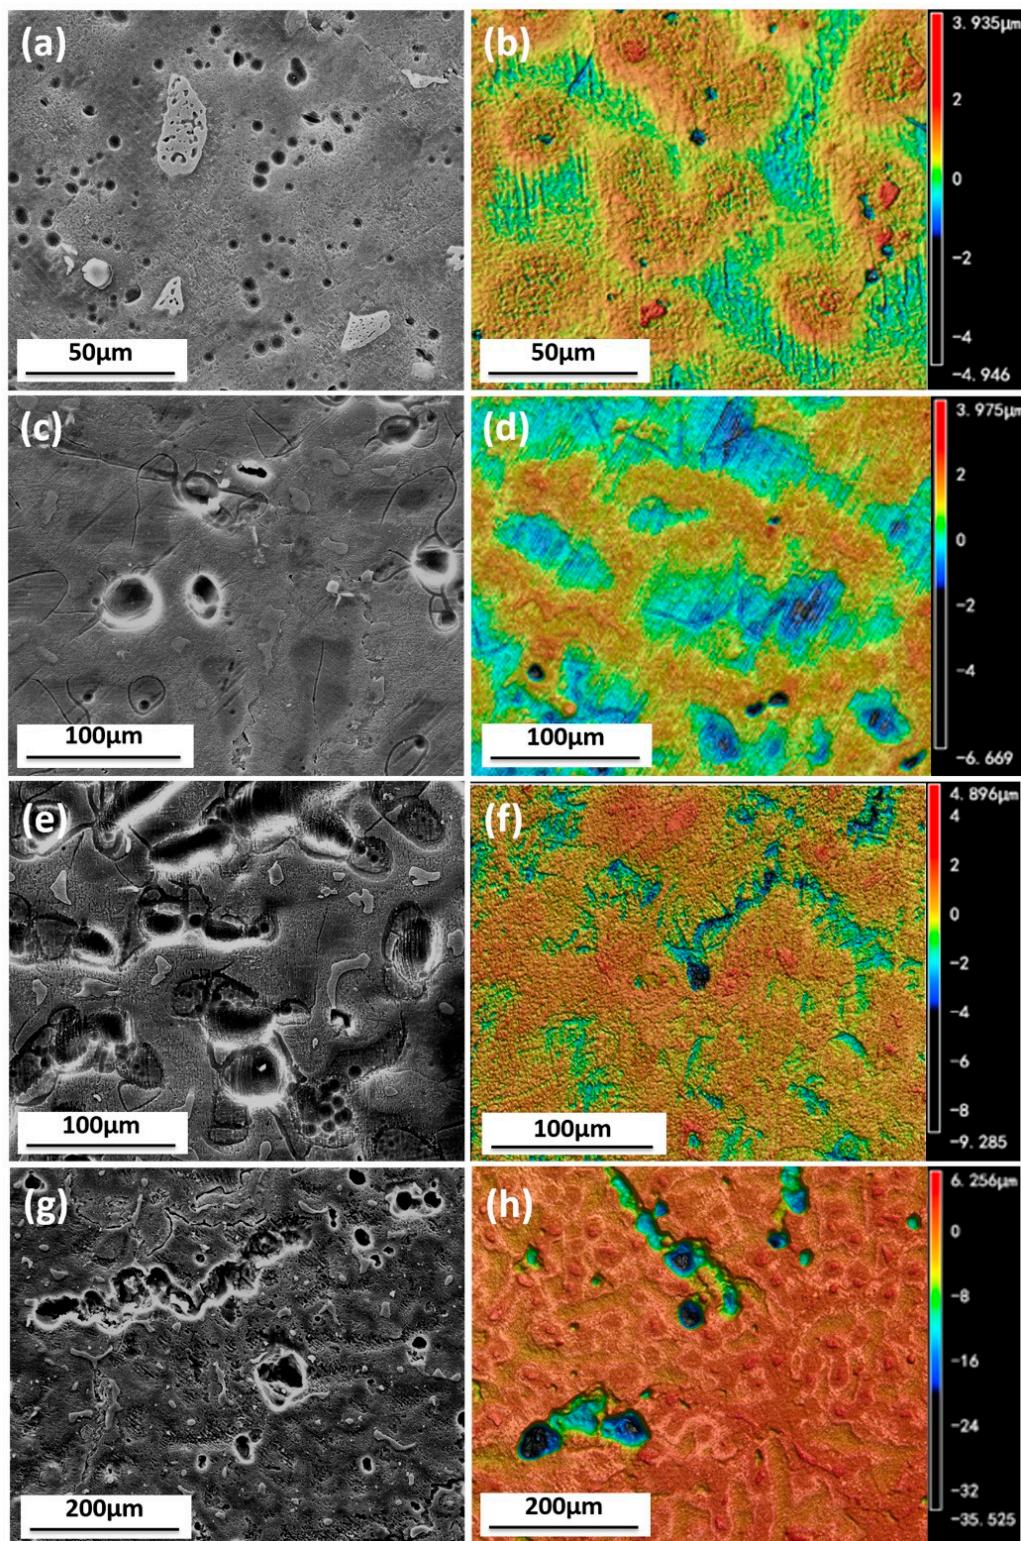
Figure 9 shows the surface morphology of samples immersed for different time, after rust removal in 1000 mL deionized water containing 200 g  $\text{CrO}_3$ , 10 g  $\text{AgNO}_3$ , and 20 g  $\text{Ba}(\text{NO}_3)_2$ . At the first 1.5 h, the pit depth on the AZ91D magnesium alloy surface in the medium was about 5  $\mu\text{m}$ , with a surface diameter of less than 3  $\mu\text{m}$ . It depicts that the corrosion was initiated from pitting corrosion. Both pit depth and surface diameter on specimen surface tended to grow with the increase of immersion time. These images reveal that small pits united and therefore big pits formed finally.

**Figure 9.** SEM (a,c,e,g) and CLSM (b,d,f,h) images of samples immersed in solution for 1.5 h (a,b), 3 h (c,d), 8 h (e,f) and 48 h (g,h) after rust removal.

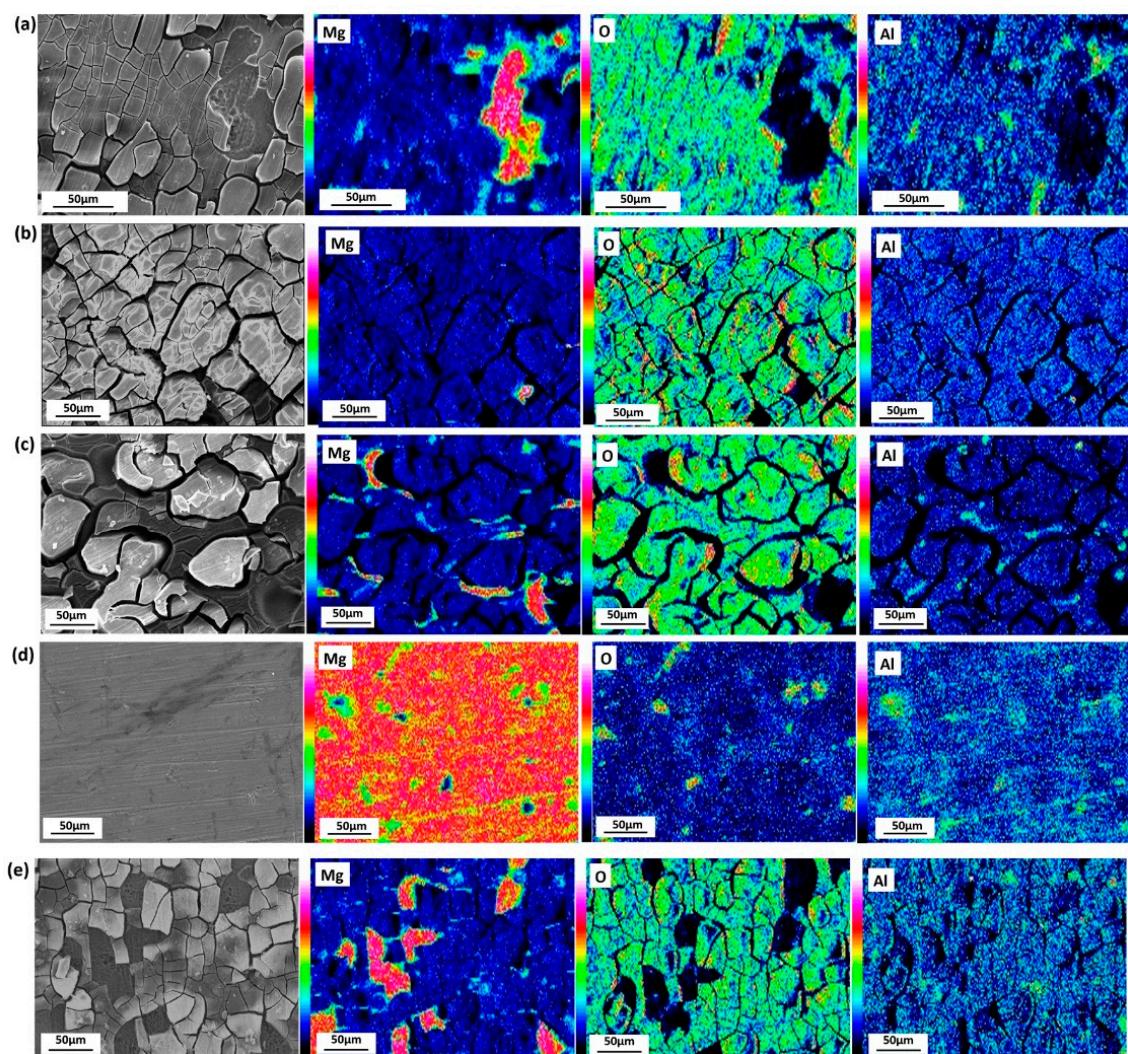
The SEM micrographs and corresponding EDX maps of the surface of the tested samples are shown in Figure 10. After 11 days immersion, the product film ruptures terribly, even slips off the bulk, and the bare Mg matrix is exposed, as shown in Figure 10a. As Figure 10b discloses, when lacking  $\text{SO}_4^{2-}$ , the film is broken evenly, but barely comes off the matrix. As can be seen from Figure 10c, when  $\text{NO}_3^-$  is absent, localized corrosion is severe, Al enrichment is found in the remaining bulk. Figure 10d shows that the surface of sample is damaged slightly when short of  $\text{NH}_4^+$ . As Figure 10e reveals,  $\text{Cl}^-$  does not show much influence towards corrosion, because the surface appearance is like that shown in Figure 10a.

**Figure 10.** SEM images and corresponding X-ray maps of Mg, Al and O for AZ91D after immersed in simulated HA solution (a), and solutions at the shortage of  $\text{SO}_4^{2-}$  (b),  $\text{NO}_3^-$  (c),  $\text{NH}_4^+$  (d),  $\text{Cl}^-$  (e) for 11 days.

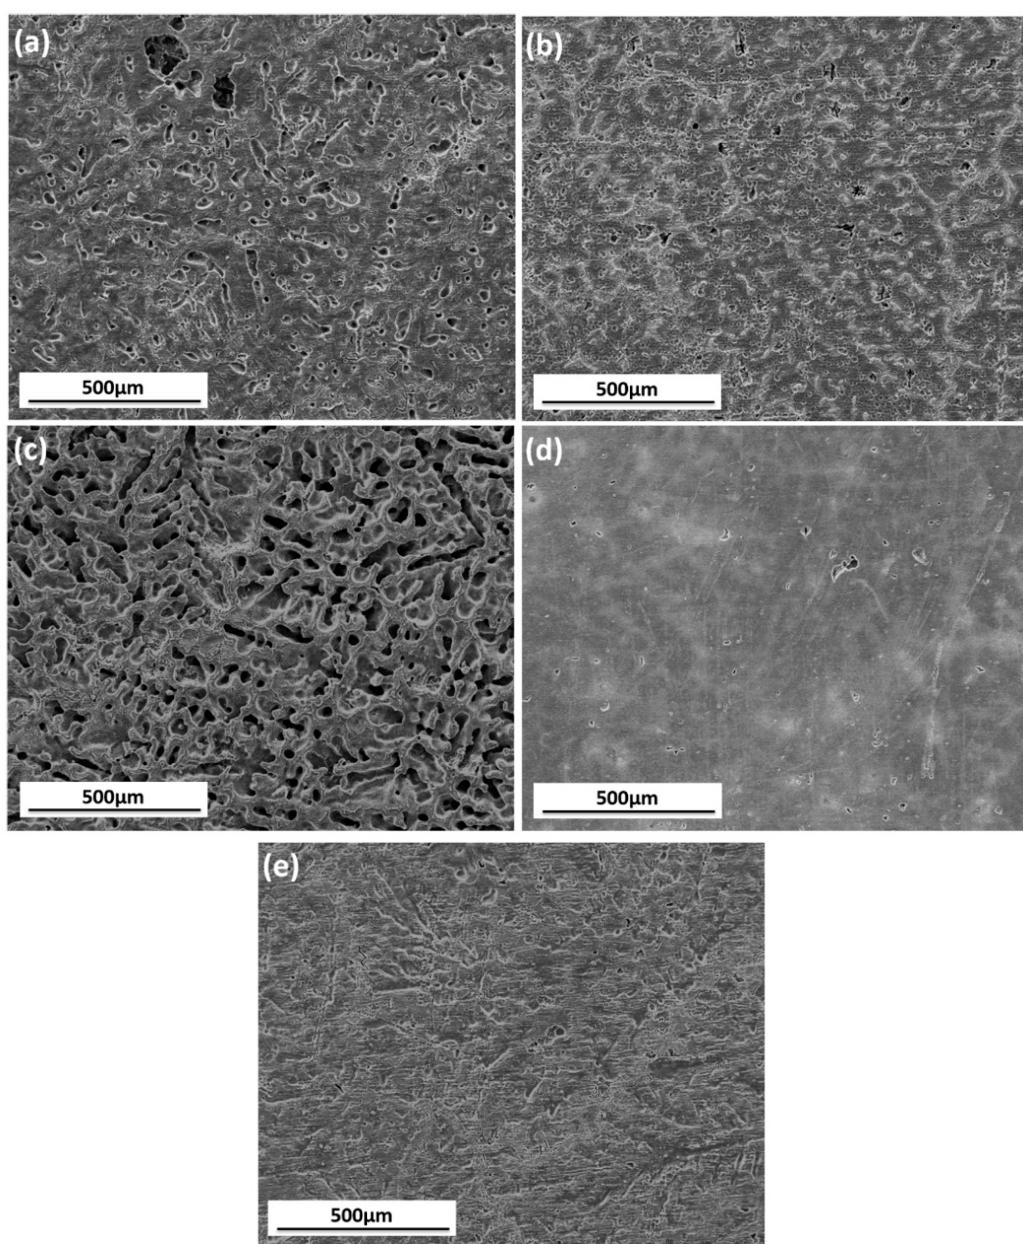
Figure 11 shows the surface morphology of tested samples after rust removal. Figure 11a shows that overall corrosion and localized corrosion develop on the surface when immersed in simulated HA solution. In the absence of  $\text{SO}_4^{2-}$ , less serious localized corrosion pits are formed on the surface, as Figure 11b shows. The morphology in Figure 11c reveals the terrible corroded surface resulting from the lack of  $\text{NO}_3^-$ , and the corrosion pits are distributed around the resistant  $\beta$ -phase network, suggesting that  $\text{NO}_3^-$  holds back the corrosion process as it does for some other metals [33]. The slight pitting corrosion shown in Figure 11d discloses that the absence of  $\text{NH}_4^+$  slows down the corrosion process drastically. The shortage of  $\text{Cl}^-$  alleviates the pitting corrosion of AZ91D (Figure 11e), indicating that  $\text{Cl}^-$  helps to develop localized corrosion. The pre-study shows that  $\text{Cl}^-$  promotes rapid attack in neutral aqueous solutions and acidic solutions [34,35].

**Figure 11.** SEM images of AZ91D immersed in simulated HA solution (a), and solutions at the shortage of  $\text{SO}_4^{2-}$  (b),  $\text{NO}_3^-$  (c),  $\text{NH}_4^+$  (d),  $\text{Cl}^-$  (e) for 11 days after rust removal.

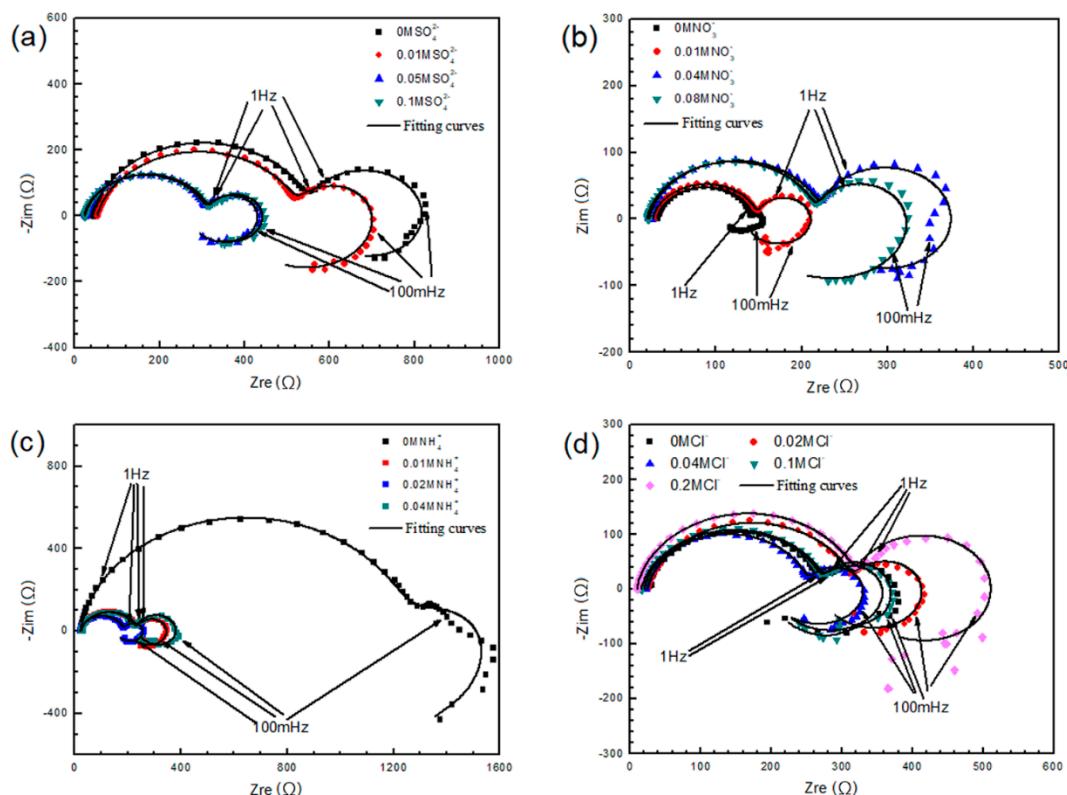
**Figure 12.** EIS dependence on  $\text{SO}_4^{2-}$  (a),  $\text{NO}_3^-$  (b),  $\text{NH}_4^+$  (c),  $\text{Cl}^-$  (d) concentration of AZ91D.

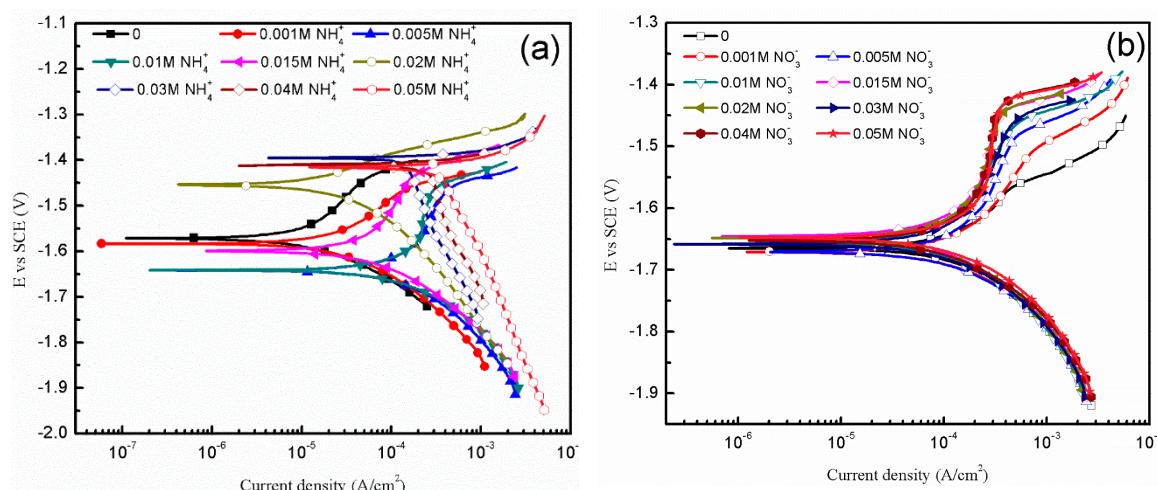
To know more about the influence of  $\text{NO}_3^-$  and  $\text{NH}_4^+$  towards specimens, further efforts were made through polarization curves, as shown in Figure 13. The corrosion potentials ( $E_{\text{corr}}$ ), corrosion current densities ( $i_{\text{corr}}$ ) and corrosion rate ( $r_c$ ) values of polarization curves in Figure 13 are summarized in Table 3.  $E_{\text{corr}}$ ,  $i_{\text{corr}}$  of the samples are obtained by the Tafel extrapolation method;  $r_c$  (mm/a) is related to  $i_{\text{corr}}$  (mA/cm) [36] using

Figure 13a reveals the anodic and cathodic polarization behaviors of the specimens exposed to solutions containing  $\text{NH}_4^+$  of 0 to 0.05 M. As the acquired curves reveal evident curvature, the Tafel extrapolation of the anodic and cathodic branches are performed using the Tafel Fit in the P4000+.

**Figure 13.** Polarization curves of AZ91D in solutions of different  $\text{NH}_4^+$  (a) and  $\text{NO}_3^-$  (b) concentration.

The identified dynamic polarized  $E_{\text{corr}}$  and  $i_{\text{corr}}$  obtained from Figure 13a are summarized in Figure 14. The values of  $i_{\text{corr}}$  show a drastic change when the concentration of  $\text{NH}_4^+$  reaches 0.005 M. The decrease of  $i_{\text{corr}}$  in solution of 0.02 M  $\text{NH}_4^+$  is likely due to the formation of corrosion product. The cathodic branch shows an extensive linear Tafel region and the cathodic current density is obviously promoted with the increasing concentration of  $\text{NH}_4^+$ . In addition, the slope of anodic branch has a tendency to decrease with the increasing concentration of  $\text{NH}_4^+$ , so it indicates that the breakdown of product coverage on corrosion surface increases the active region of corrosion reaction [37]. It can be inferred that  $\text{NH}_4^+$  hinders the formation of product hydroxide/oxide film by the consuming  $\text{OH}^-$ . As shown in Table 3, the corrosion rate of AZ91D increases nearly tenfold from 0.8598 mm/a to 6.882 mm/a when  $\text{NH}_4^+$  changes from 0.001 to 0.005 M. When  $\text{NH}_4^+$  reaches 0.02 M, the corrosion rate drops down due to the protective film. However, as  $\text{NH}_4^+$  concentration increases, the corrosion rate increases linearly. Former study indicates that the corrosion rate of AZ91D immersed in 1 M NaCl solution is 0.91 mm/a [36], close to the corrosion rate of AZ91D immersed in simulated HA solution with 0.001 M  $\text{NH}_4^+$ . It indicates that  $\text{NH}_4^+$  is largely responsible for the terrible corrosion behavior in simulated HA solution.

Figure 13b shows the potentiodynamic polarization curves of samples immersed in solutions containing  $NO_3^-$  of 0 to 0.05 M. There is little difference among cathodic Tafel slopes, reflecting similar electrochemical reactions of hydrogen evolution. Table 3 shows that the values of  $E_{corr}$ ,  $i_{corr}$  and  $r_c$  fluctuate slightly with the change of  $NO_3^-$  concentration. However, Figure 11c reveals that  $NO_3^-$  does have an important influence on the corrosion behavior. It can be seen from Figure 13b that with the increasing concentration of  $NO_3^-$ , the slope of anodic branch increases, indicating more passive product film coverage on the corrosion surface. Therefore, the protective role  $NO_3^-$  plays can be attributed to the formation of passive product film.

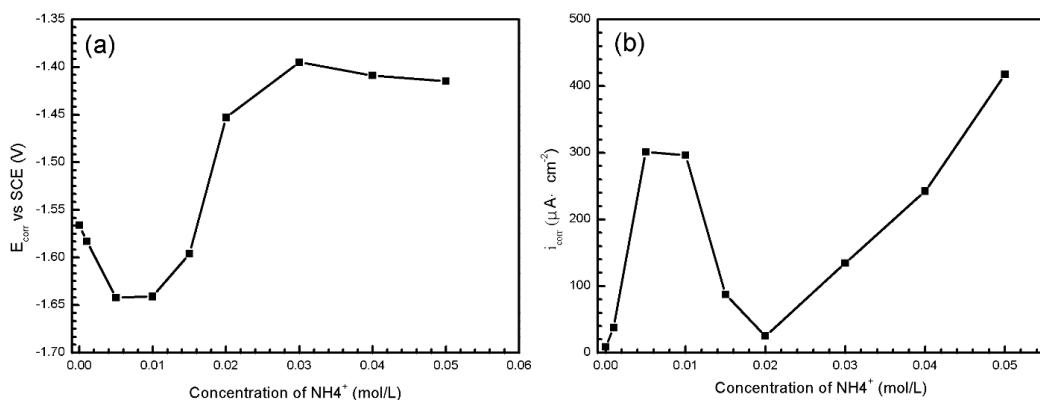
**Figure 14.** The  $E_{corr}$  (a) and  $i_{corr}$  (b) values of samples in Figure 13a.

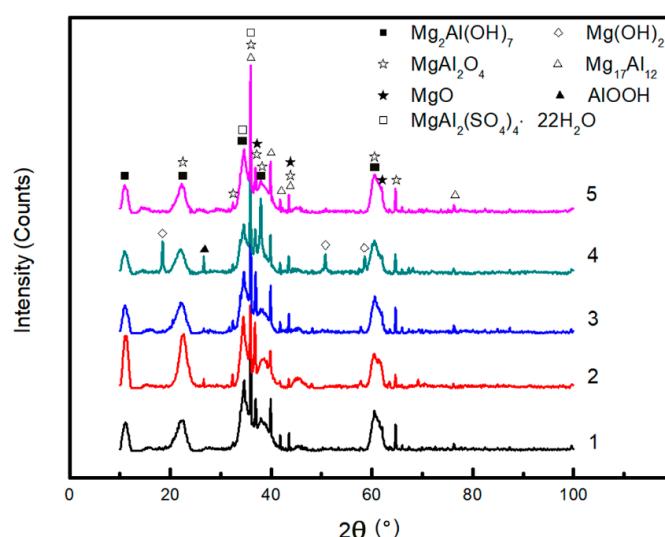
After the immersion test, the corrosion product slipping off was collected and powdered to be analyzed through XRD. As shown in Figure 15, MgO and  $MgAl_2O_4$  are the main corrosion products. As shown in No.2 XRD pattern, the absence of  $SO_4^{2-}$  results in an evidently lower  $MgAl_2(SO_4)_4 \cdot 22H_2O$  peak, indicating that  $MgAl_2(SO_4)_4 \cdot 22H_2O$  is also an important product. It reveals from the No.4 XRD pattern that the product collected in solution lack of  $NH_4^+$  contained  $Mg(OH)_2$ , which barely exists in other results, identifying  $NH_4^+$  accelerates corrosion by consuming  $OH^-$  in a straightforward way.

**Figure 15.** XRD patterns for the product of AZ91D after immersed in simulated HA solution (1), and at the shortage of  $SO_4^{2-}$  (2),  $NO_3^-$  (3),  $NH_4^+$  (4),  $Cl^-$  (5) for 11 days.

The main corrosion products of AZ91D immersed in simulated HA solution for 11 days were  $\text{MgO}$ ,  $\text{MgAl}_2\text{O}_4$  and  $\text{MgAl}_2(\text{SO}_4)_4 \cdot 22\text{H}_2\text{O}$ , as shown in Figure 15. The reason why  $\text{Mg(OH)}_2$  was absent was that  $\text{NH}_4^+$  consumed  $\text{OH}^-$ , therefore  $\text{Mg}^{2+}$  could not combine with  $\text{OH}^-$  to form protective  $\text{Mg(OH)}_2$  film. Without the protection of  $\text{Mg(OH)}_2$ , the corrosion was more serious, which could be proved by Figures 11d and 12c. It should be noted that with the development of corrosion,  $\text{NH}_4^+$  ran out around the localized corrosion pits, the resistant  $\beta$ -phase began to react with  $\text{OH}^-$ , leading to the formation of  $\text{Mg}_2\text{Al(OH)}_7$  and  $\text{AlOOH}$ .

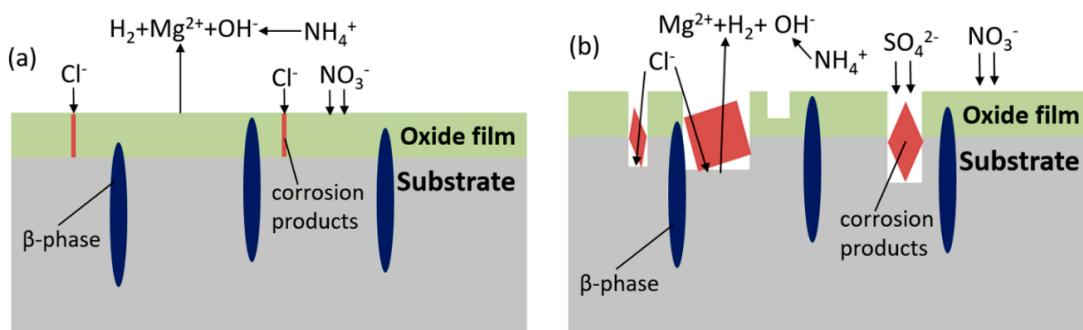
Taking into account both the corrosion process of AZ91D in the simulated HA solution and the influence of ions, a schematic diagram consisting of two stages is proposed (Figure 16) in order to explain the corrosion mechanism of AZ91D in simulated HA solution.

Therefore, the product film is formed once the sample is exposed to the solution, and the main components refer to MgO instead of Mg(OH)<sub>2</sub>. The existence of NO<sub>3</sub><sup>-</sup> helps to form a passive film on the surface, so the corrosion rate is soon limited. Cl<sup>-</sup> brings about the localized corrosion, therefore tiny corrosion pits appear where the sites are active.

- Second stage (shown in Figure 16b). As the corrosion develops, the resistant  $\beta$ -Mg<sub>17</sub>Al<sub>12</sub> dissolves, thus aluminum concentration elevates and the precipitation of MgAl<sub>2</sub>(SO<sub>4</sub>)<sub>4</sub>·22H<sub>2</sub>O is formed according to Reaction (2), resulting in a higher corrosion rate. Corrosion continues to develop in pits, where bare  $\alpha$ -matrix is firstly to be corroded and NH<sub>4</sub><sup>+</sup> is consumed up by OH<sup>-</sup>, then  $\beta$ -phase reacts with OH<sup>-</sup>, generating Mg<sub>2</sub>Al(OH)<sub>7</sub> and AlOOH. Cracks generally appear on the coverage and film drops out, even in a severe process, Mg particle surrounded by completely corroded material falls into solution, resulting in bare Mg exposed to the solution. Meanwhile, SO<sub>4</sub><sup>2-</sup> and Cl<sup>-</sup> keep attacking to form deeper pits.

**Figure 16.** Corrosion process diagram of AZ91D consisting of a first stage (a) and a second stage (b) immersed in HA solution.
