Article

Low Velocity Impact Behavior of Glass Filled Fiber-Reinforced Thermoplastic Engine Components

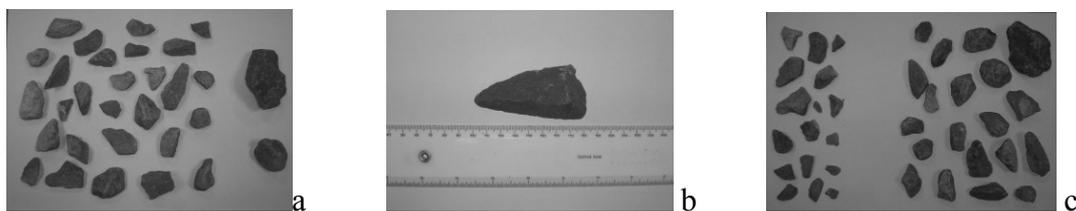
Figure 1. Selection of random stones collected on the road.

In order to quantify the size of stone likely to cause damage to an oil pan, a search and a selection of random granite stones are collected from regular roads (Figure 1). This approach is taken to allow measurement of the mass and size of road stones. The granite stones shown on the left of Figure 1a weigh less than 17 grams and all fit into the damaged area between two consecutive ribs. The two stones on right do not fit; the rounded stone weighs 21 grams and the larger stone weight 78 grams. There are variable gaps between the ribs in the area of impact. A 87 gram random stone with a triangular profile is able to fit into the gap where damage is evident (Figure 1b). A possible solution would be to reduce the rib spacing (Figure 1c) so as to exclude more stones.

and it also allows a more stable trajectory, and further allows the length of the pointed end to penetrate into structures as would happen with a typical stone shown in Figure 1(b).

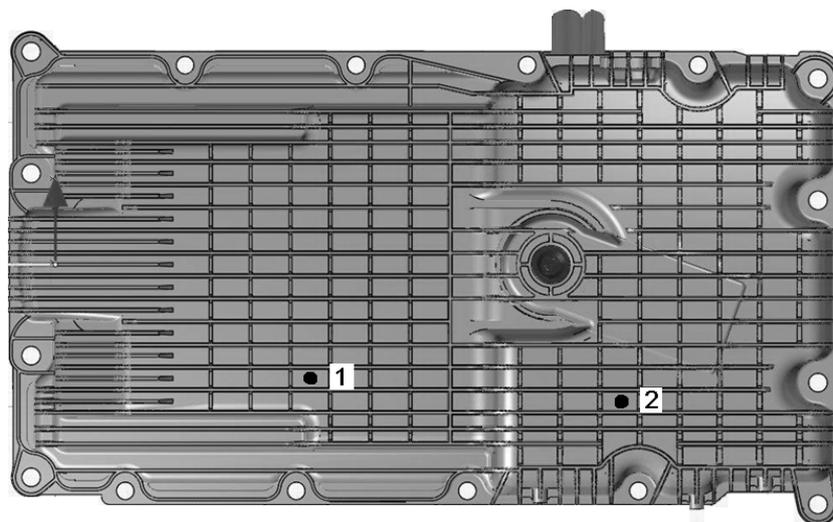
Figure 3. Two different impact locations highlighted.

The drop-weight tower allows accurate impacts on the desired target. Many impact positions were tested (over 1000 impacts taken) on different oil sumps and at different velocities. Figure 3 shows two locations that are representatives of all the impacts positions of the bottom oil pan.

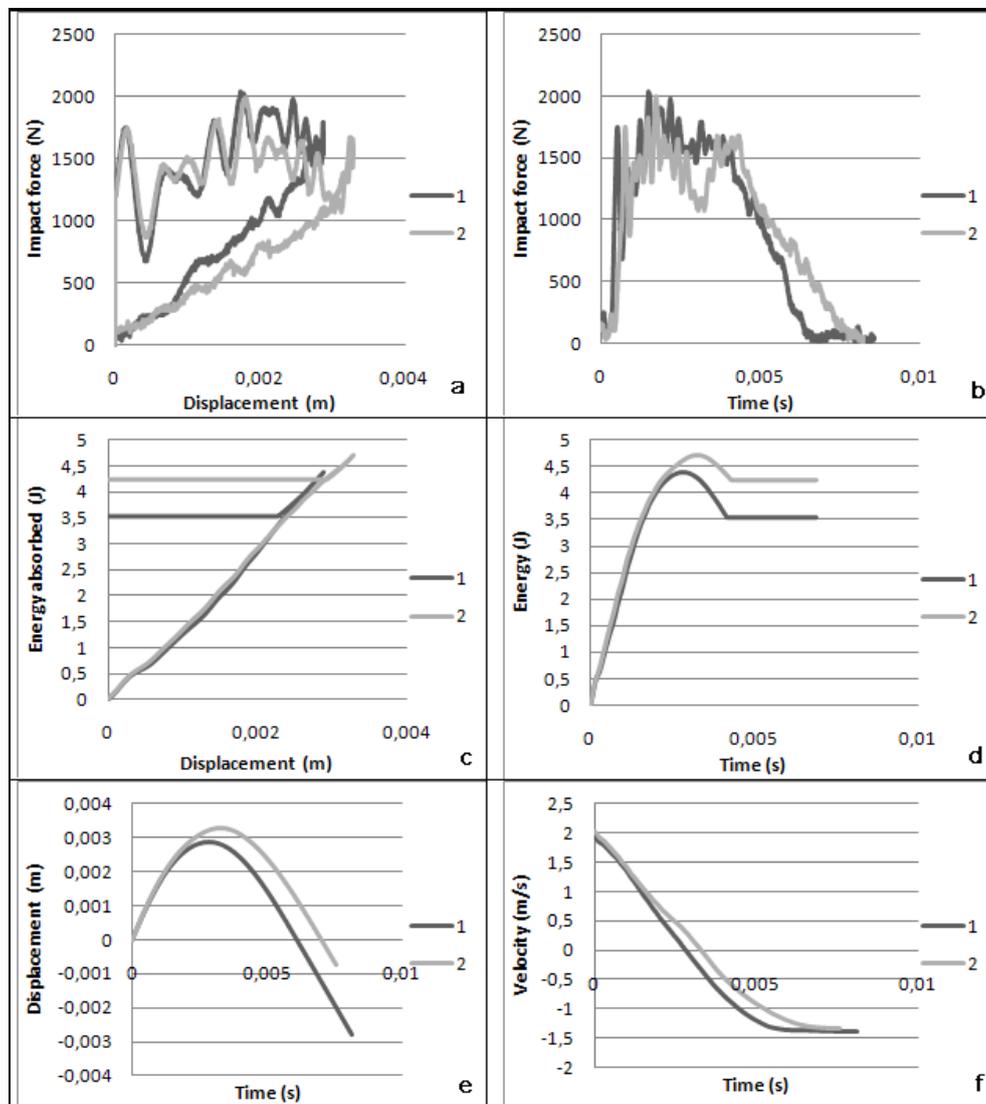
Figure 4. Data obtained after a 2.28 kg falling weight impact onto the oil pan at 5 Joules.

The magnitudes measured are force, displacement, energy, impact velocity and the duration time of the event. The forces histories in Figure 4a and Figure 4b show a large oscillations zone which can be an indication of material damage. When the force between the oil pan and the impactor returns to null, it is the end of contact time and the end of penetration. Figure 4a shows closed loops in which the area under the curve is the deformation energy that is initially transferred from the impactor to the oil pan surface and then given back from the oil pan surface to the rebounding impactor. The area included inside the loop refers to the energy absorbed during the impact. In the Figure 4c and Figure 4d, the energy grows until the maximum displacement is reached (3 mm) then the energy decreases until the impactor detaches from the oil pan surface. We consider that from this point to the end of the test, the oil pan surface does not dissipate energy any further, only releasing the residual part of the elastic energy stored during the penetration of the impactor. At the final instant, the energy value shown in the graph is equal to the dissipated energy. It is important also to notice that the maximum energy level is equal to the initial kinetic energy of the impactor. The maximum deflection for these tests was around

3 mm (Figure 4a and Figure 4c). They show that the component has recovered its initial position as deflections return to zero. The impact has reached its maximum penetration into the oil pan surface (Figure 4e) when the impactor velocity becomes zero (Figure 4f) [19].

According to the charts in Figure 4, it seems that the structure, and more specifically the impacted surfaces, have undergone the efforts in two different ways. There is a distinction to be made between impact 1 and impact 2. For impact 2, the forces histories demonstrate that the structure has undergone micro-damages if we look at the variations in force intensities before reaching the maximum force. The displacement histories confirm that the structure has recovered its initial position after oscillation and been displaced with the return to zero. The energy histories illustrate the energy absorbed by the component which is actually practically equal to the impact energy transferred by the impactor. Impact 2 has passed successfully the test as defined previously, however there was an oil pan rib broken which can be seen in the Figure 4b when the curve is falling down before beginning to increase again (at 3 ms). For impact 1, there is a small difference which could have an opposite outcome. The force history is quite similar to the other impact scenarios studied. Nevertheless, it is important to note that

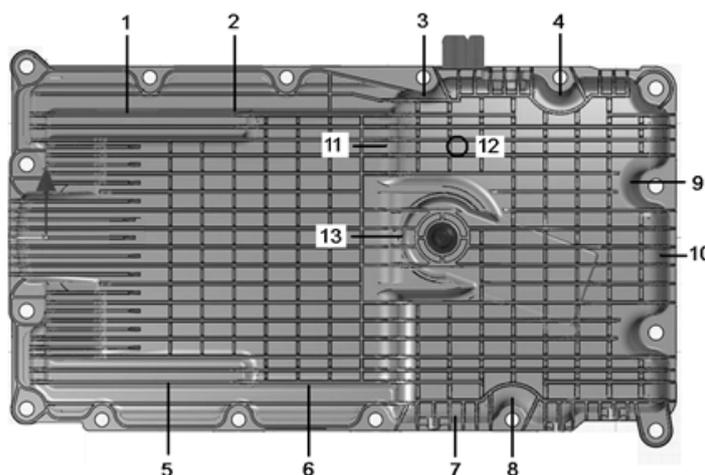
Figure 5. Map of the impact locations.

The 22 gram projectile was fired at the oil pan for a single impact perpendicular to the surface (Figure 5 and Figure 6). The impacts were reproduced at least four times using a new oil pan at each time.

Figure 5 shows some of the impacts realized on the oil pan. Depending on their location, the impact intensity used is variable. Figure 6 provides details of the impact energies applied for each impact location and the outcomes for each shot indicated in terms of percentage of failure in part integrity.

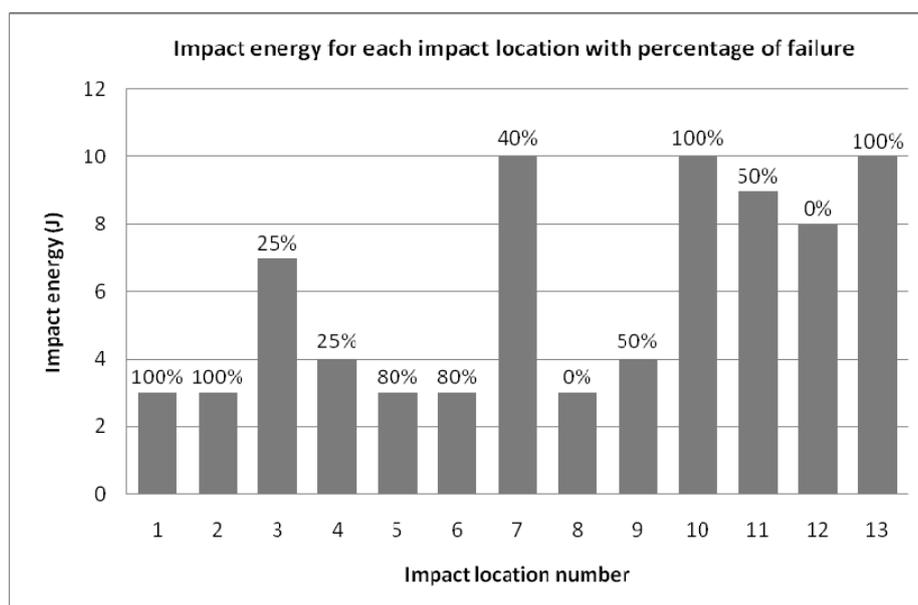
Figure 6. Percentage of failure for each impact location at different impact energies.

Figure 6 shows an overview of the impact limits that the oil pan can withstand and points out where the areas of weakness exist. The disparity in terms of impact resistance is clear. This is due to the complexity of the oil pan in its structure (with surfaces more or less stiffened in the inside of the oil pan) and its material arrangement (*i.e.*, fiber direction arrangement). The understanding of material failure is not easy. This judgment is blurred by the complexity of the material. Nevertheless, a resistance limit more or less constant was determined for each location shown in the map (Figure 5). Explicitly, the unlikely sides to receive an impact have to undergo 3-4 Joules, the edges of the pan and some medium level risk sides have to withstand 7-8 Joules. The most exposed areas should be able to withstand 10-12 Joules. The sides likely to fail in Figure 6 have to be improved, redesigned or stiffened. As expected, the ribbing is the relevant geometric parameter. It plays a big part in the impact resistance of the component. In addition, it is evident that the ribbing dimensions should be contained following the following values. The rib height should be between 4 to 10mm and for a height between 2-3 mm. For ribs less than these dimensions, it seems that the ribs are less efficient while above this height, the ribs are too fragile and brittle. Figure 7 shows various damage types that can result after an impact.

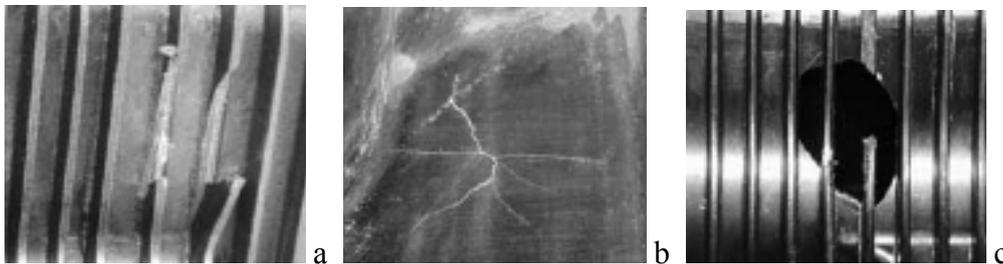
Figure 7. Damage types that can result after an impact. Broken ribs (a), Interior cracks (b), Perforation (c).
