# COASTAL ENGINEERING

## Chapter 24

### HISTORY OF THE GALVESTON SEA WALL

Albert B. Davis, Jr.  
Chief, Planning and Reports Branch  
Galveston District, Corps of Engineers  
Galveston, Texas

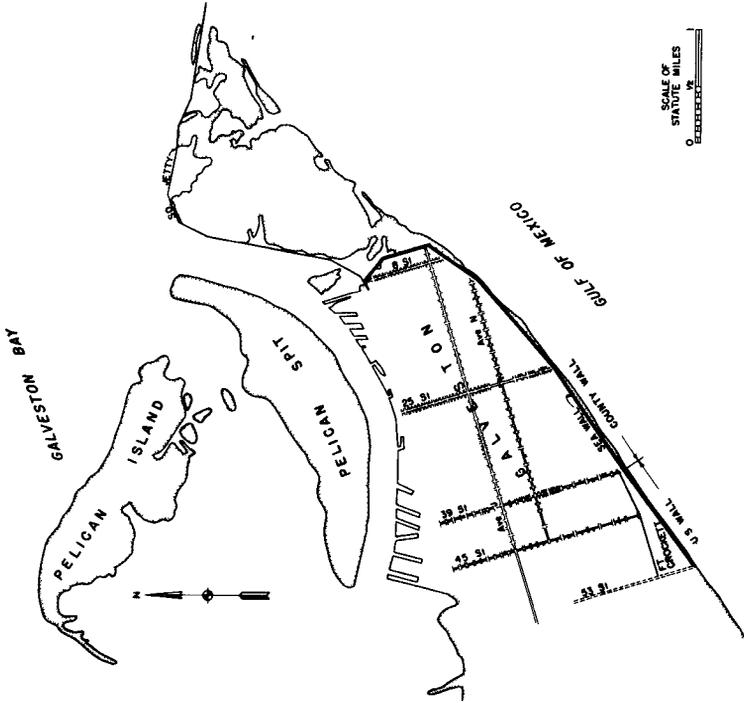
Fig. 2.  
Galveston Island showing initial sea wall construction by Galveston County and the United States.

a. A solid concrete wall, over 3 miles long, connecting with the south jetty near 8th Street; thence to 6th Street and Avenue D; and thence on 6th Street across the island to the beach and down the beach as far as 39th Street. The top of this wall to be 17 feet above mean low water. The location of this sea wall would be landward of the highwater line generally at about the 3-foot contour as shown on figure 2.

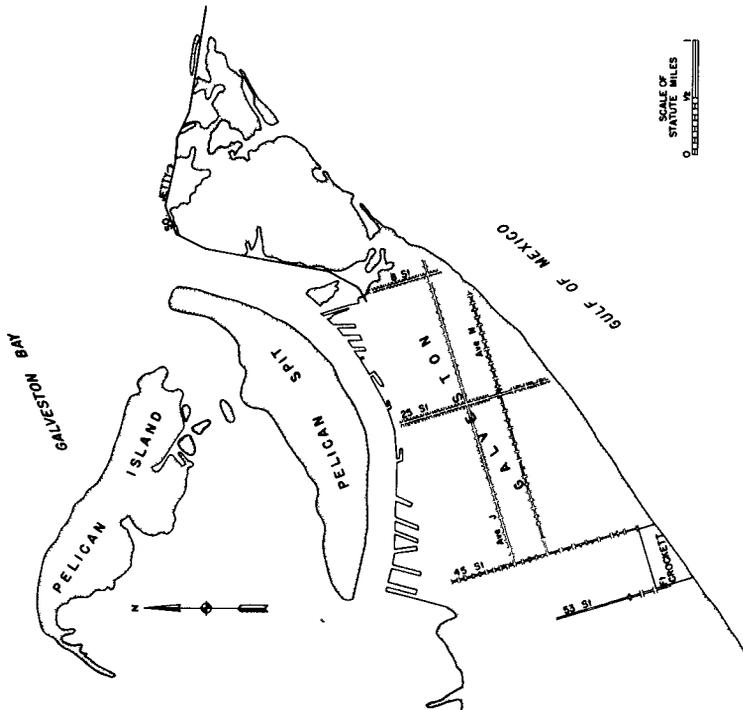
Fig. 1.  
Galveston Island about 1900.

Galveston Island, one of the long narrow barrier beaches that fringe the Gulf Coast of Texas, is a low, sandy formation about 28 miles long and from  $\frac{1}{2}$  to 3 miles wide. In its natural state the Gulf shore was bordered by an area of sand dunes rising to heights of 12 to 15 feet above the natural surface of the island. The availability of deep water along the bay side of the island led to the early development of the city of Galveston on the east end of the island. In its early days the city was protected from hurricane tides by the sand dunes along the Gulf front. The rapid development of the city in the latter part of the 19th century, especially its increasing importance as a summer resort, led to the removal of the sand dunes along the beach front for fill and to permit easy access to the beach. Without the dunes the city was unprotected from the fury of the hurricanes. The danger to the city was realized by a number of persons, and several plans for storm protection had been developed; however, because of financing difficulties and general public apathy none of these plans was carried out. Figure one shows a map of Galveston Island with development as it was in 1900.

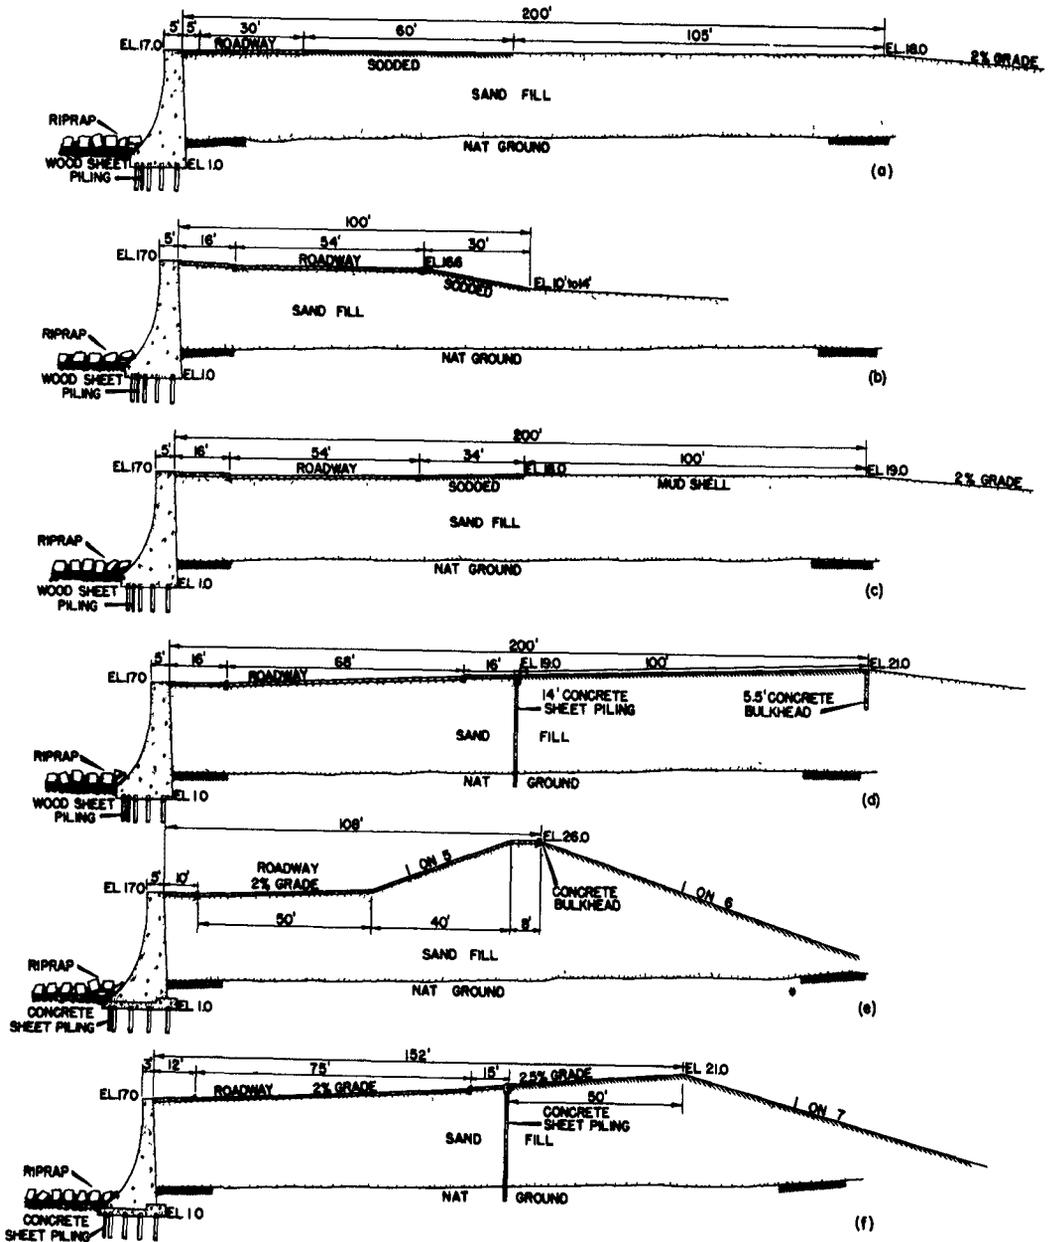
Fig. 3. Cross sections of the sea wall.  
 a. As proposed by the Roberts Board.  
 b. As initially built by Galveston County.  
 c. As modified after the 1909 storm.  
 d. As modified after the 1915 storm.  
 e. As built in front of Fort San Jacinto.  
 f. Authorized 3-mile west extension.

c. The making of an embankment on top of this fill adjacent to the wall, and rising to a height of 18 feet above low water at a distance of 200 feet from the wall, thence sloping down on a grade of 1 in 50 to the surface of the fill. The top of this embankment for 35 feet from the sea wall to be protected by a brick pavement and 60 feet farther by Bermuda grass. A section of the structure proposed by the Roberts Board is shown on figure 3a.

behind the concrete section was built only 100 feet wide and to a maximum elevation of 16.6 feet. The wall as built is shown on figure 3b.

The toe of the wall was repaired by placing sand and riprap to bring the riprap up to grade. As a result of the damage to the embankment caused by this storm it was decided to repair the embankment behind the wall and extend the fill to a crest elevation of 19 feet at a distance of 200 feet from the face of the concrete section as originally proposed. The section as repaired and modified after the 1909 storm is shown on figure 3c.

Figure 3d shows this modification.

A somewhat different design was used for the embankment behind the sea wall across the San Jacinto Reservation. Here the embankment behind the wall has a 10-foot walk and 50-foot roadway that slope up on a 2 percent slope and then the embankment rises on a 20 percent slope for 40 feet to a crest of the fill at elevation 26 feet. The crest is 8 feet wide and there is a concrete cut-off wall along its landside that extends one foot above the top of the fill. Behind the cut-off wall the fill has a 1 on 6 slope to the natural ground at a distance of about 250 feet from the face of the concrete wall. The front slope and crest of the embankment are paved. This embankment is designed to prevent any overtopping of the fill by storm waves. A section of this wall is shown on figure 3e.

The protection that the sea wall afforded the city of Galveston encouraged development of the city. The protected area became densely occupied with houses and at present there is little undeveloped land, protected by the sea wall, available for expansion of the city. Development has taken place toward the southwest beyond the sea wall, despite the danger of destruction by hurricanes. In order to afford protection to this area, Congress in 1950 authorized construction of a 3-mile southwest extension of the Galveston sea wall, similar in design to the existing wall. The riprap at the toe of the wall is 40 feet wide and the embankment behind the wall rises to an elevation of 21 feet at a distance of 155 feet from the face of the wall. The top of the wall is reduced to a width of 3 feet. A section of the proposed wall is shown on figure 3f. The authorization provides that local interests contribute

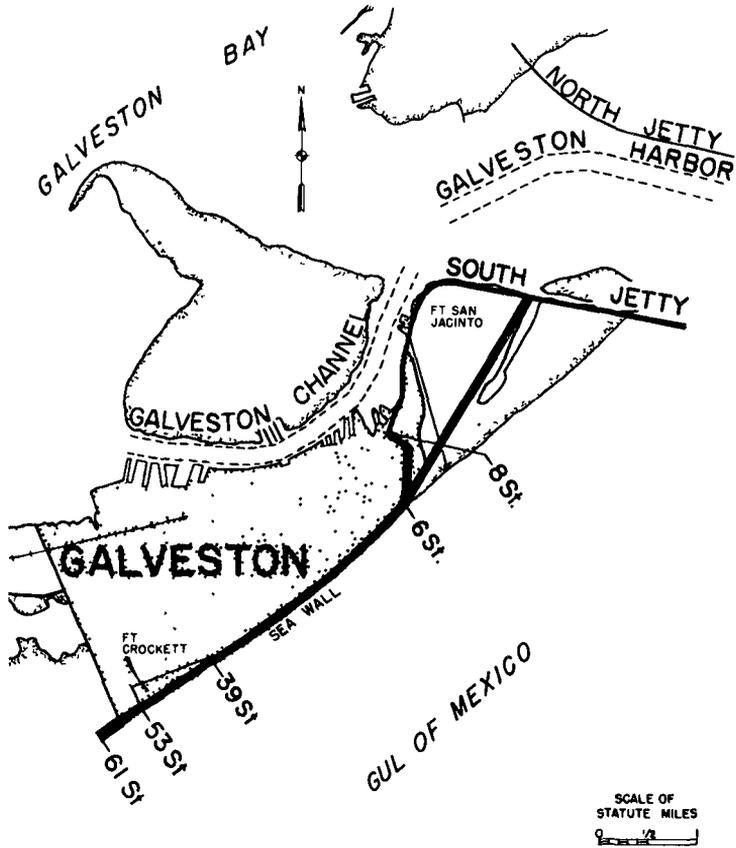
Fig. 4. Galveston Island showing sea wall extension to the south jetty and to 61st Street.

3,300 feet would be built by the local interests, city or county, and 7,000 feet on the Fort San Jacinto Reservation would be built by the United States. This proposed extension is shown on figure 4. The design of the sea wall extension was the same as the completed sea wall with the embankment behind the wall 200 feet wide from the edge of the wall to the crest of the fill.

On July 27, 1916, Congress authorized the east extension of the sea wall from 6th Street to Fort San Jacinto as recommended by the board of engineers in 1913. This extension is shown on figure 4. Work on this extension was begun on June 20, 1918. The work was very much delayed by wartime labor shortages and lack of materials because of embargoes on railroad cars. The extension was about half completed, having reached the edge of an old borrow pit about 200 feet wide and  $2\frac{1}{2}$  feet deep from which about 3,000,000 cubic yards of material had been removed for the Galveston grade raising, when the severe hurricane of September 13-14, 1919, occurred. The borrow pit had been closed with a wood sheet pile bulkhead and work of constructing the sea wall across the area was in progress when the storm occurred. This storm passed about 180 miles south of Galveston but it caused a tide of 9.0 feet above mean low tide and winds of about 60 miles an hour at Galveston.

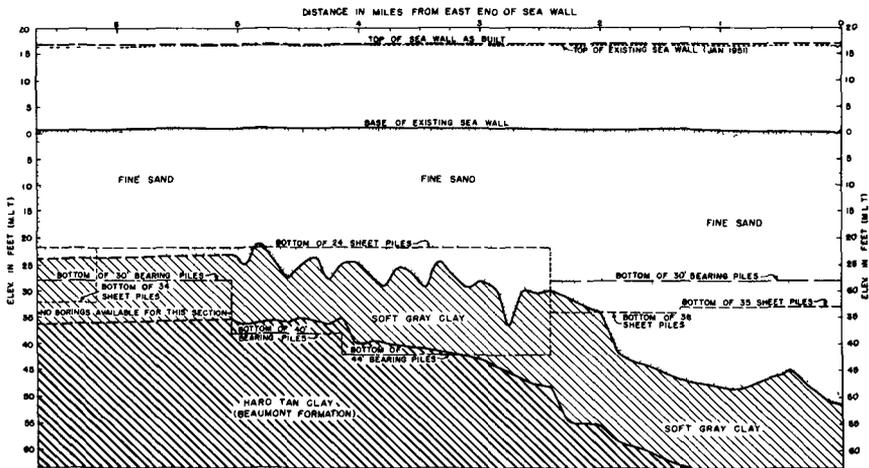
Fig. 5. Soils profile along the existing sea wall.

A profile of the sea wall from 61st Street to the south jetty is shown on figure 5. This profile shows the subsurface strata which consists of about 25 feet of sand underlain by 10 feet of soft clay below which is the heavy clay of the Beaumont Clay formation. The east end of the profile shows the erosion of the gorge of Galveston pass. The bearing piles under the wall are generally seated in the clay strata, except in the east end where the depth to clay is too great, and the section west of 39th Street where short piles were used.

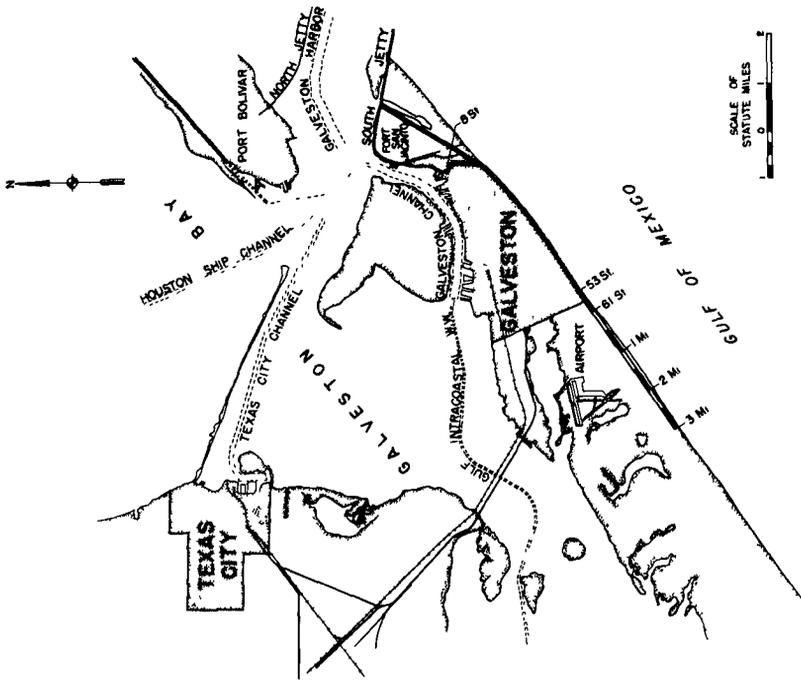
Fig. 7. Galveston Island showing authorized 3-mile west extension of the sea wall.

\$2,870,000 toward the cost of the project, estimated at about \$9,000,000. The estimated cost is about \$550.00 a linear foot of wall. No Federal funds have been appropriated by Congress; however, Galveston County has contributed its share to the Corps of Engineers and construction of 5,151 feet of the extension is now under way. (Fig. 7).

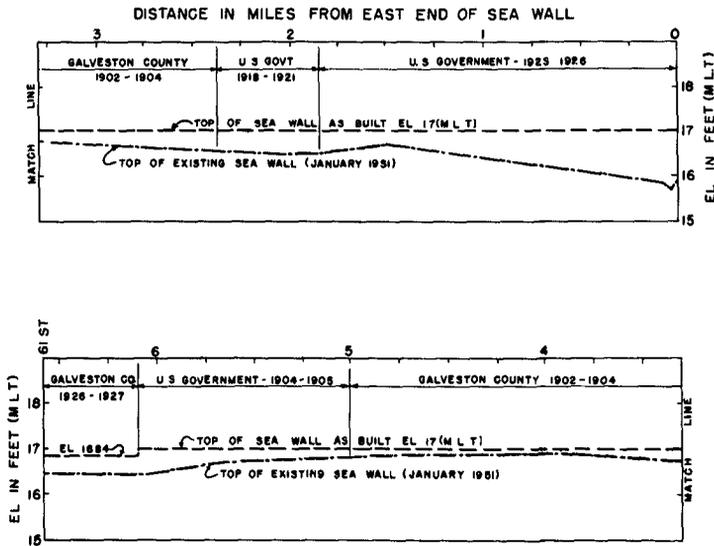
Fig. 6. Profile of the top of the existing sea wall showing settlement.

The profile of the top of the wall, in figure 6, shows the extent of settling that has occurred in the wall. The oldest part of the sea wall has settled least because of the use of longer bearing piles, the tips of which extend into or near the Beaumont Clay formation. Settlement of the wall has been caused, mainly, by consolidation of the soft gray clay beneath the tips of the piles that do not reach the Beaumont Clay. Settlement has been very uniform at any one locality along the sea wall and no cracking or shifting of the monoliths is evident. Settlement has been continuous since the sea wall was constructed and apparently is continuing. The greatest settlement occurred in the east end of the sea wall which was constructed over recent deposits. Here the soft gray clay layer is much thicker and it appears that this area was the entrance to Galveston Bay until the last few centuries. Settlement ranges from 1.45 feet near the east end of the wall to a mere 0.1 foot near the central portion of the County wall about at 27th Street which was built in 1902-04.
