SKYLAB D024 THERMAL CONTROL COATINGS AND POLYMERIC FILMS EXPERIMENT

William L. Lehn
Nichols Research Corporation
4141 Col. Glenn Highway
Dayton, OH 45431

INTRODUCTION

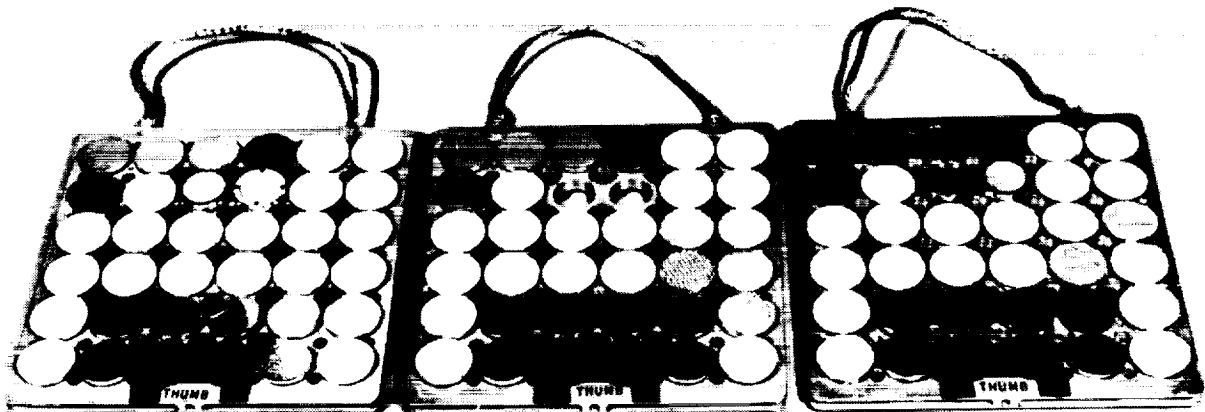
Figure 3. Comparison of D024 Control and SL1/2 and SL1/3 Thermal Control Specimens

The degradation/darkening of the thermal control coatings recovered by SL1/2 and SL 1/3 crews is apparent when compared with a set of preflight controls as shown in figure 3. The excessive discoloration is a result of excessive contamination followed by degradation/darkening of the contaminant layer by the solar exposure.

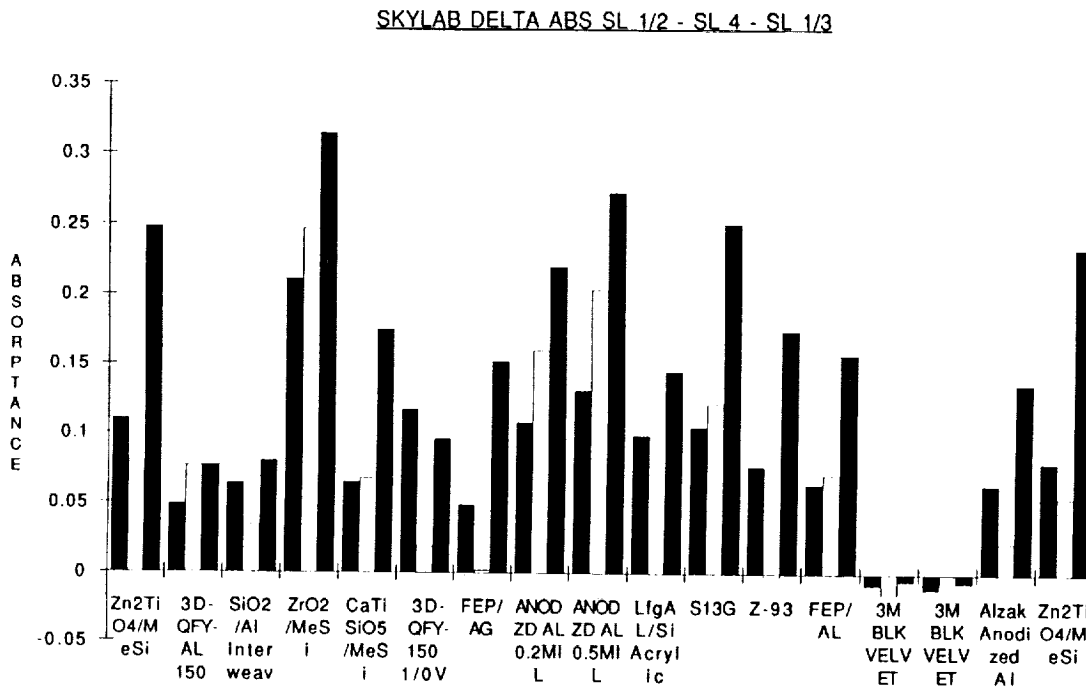
Figure 5. Solar Absorptance Changes for Thermal Control Coatings(Sl 1/2, SL 4, SL 1/3)

The changes in solar absorptance for the thermal control coating materials flown on the three D024 Thermal Control Coating Trays have been plotted to show the changes which occurred and are shown in figure 5 and figure 6. The solar exposure times are: SL 1/2, 35 days/550 hours; SL 4, 74 days/1150 hours; and SL 1/3, 131 days/2040 hours. The primary increase in absorptance is due to the presence of contamination on the surfaces of the coatings. The degradation due to damage to the coating itself is largely obscured. There is some indication of the decrease in contamination level, lower values of absorptance for the SL 4 specimens. The values for the Ag and Au coated Sloan thickness monitor are not plotted. The Ag specimens were all severely oxidized all the way through the thickness to a blue/black amorphous mass. Areas of the Ag surface protected by the mechanical retaining ring were unchanged.

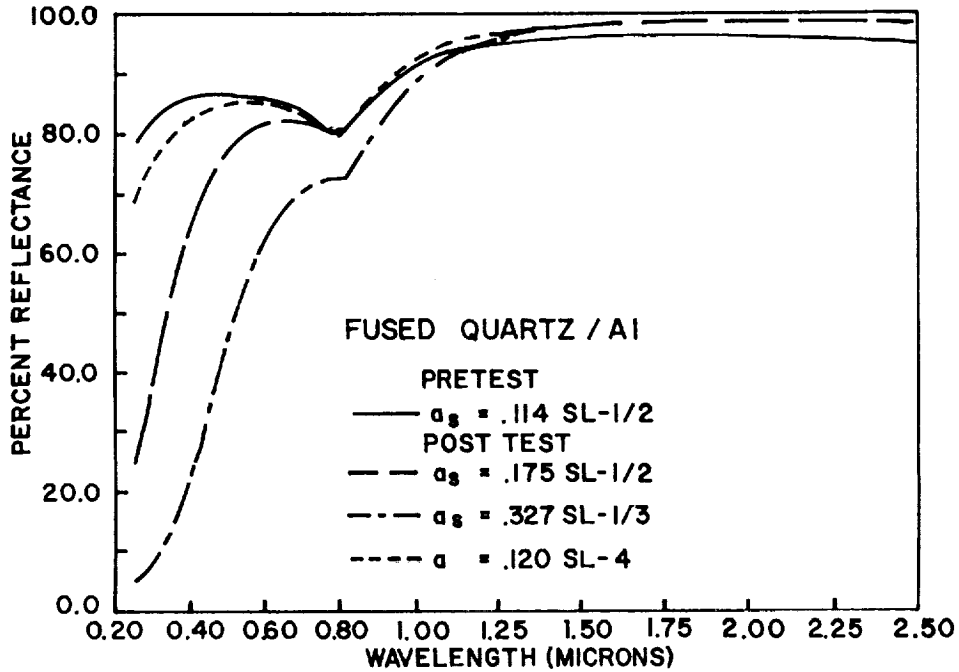
Figure 7. Effect of Skylab on Fused Quartz/Al

The effects of the Skylab exposure on a fused quartz/Al second surface mirror/OSR are shown in figure 7. The excessive degradation is attributed to the excessive contamination associated with the Skylab environment followed by further fixing and degradation of the contaminant layer by continued solar exposure.

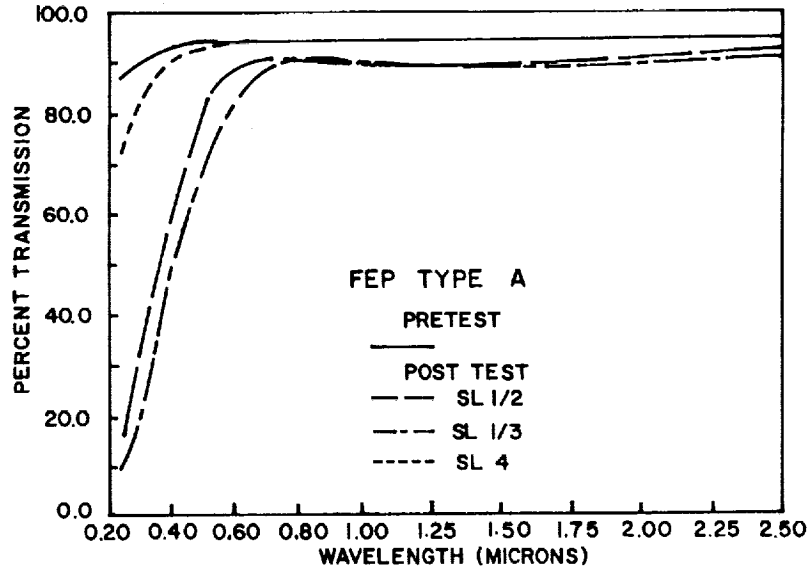
Figure 8. Effect of Skylab Exposure on FEP Type A

The degradation in transmission of a sample of FEP Type A shows the effects of the contaminant layer. Comparison with the reflectance data of samples of FEP/Ag flown on LDEF are quite similar in appearance and indicate the presence of a degraded contamination layer as shown in figures 8 and 9.

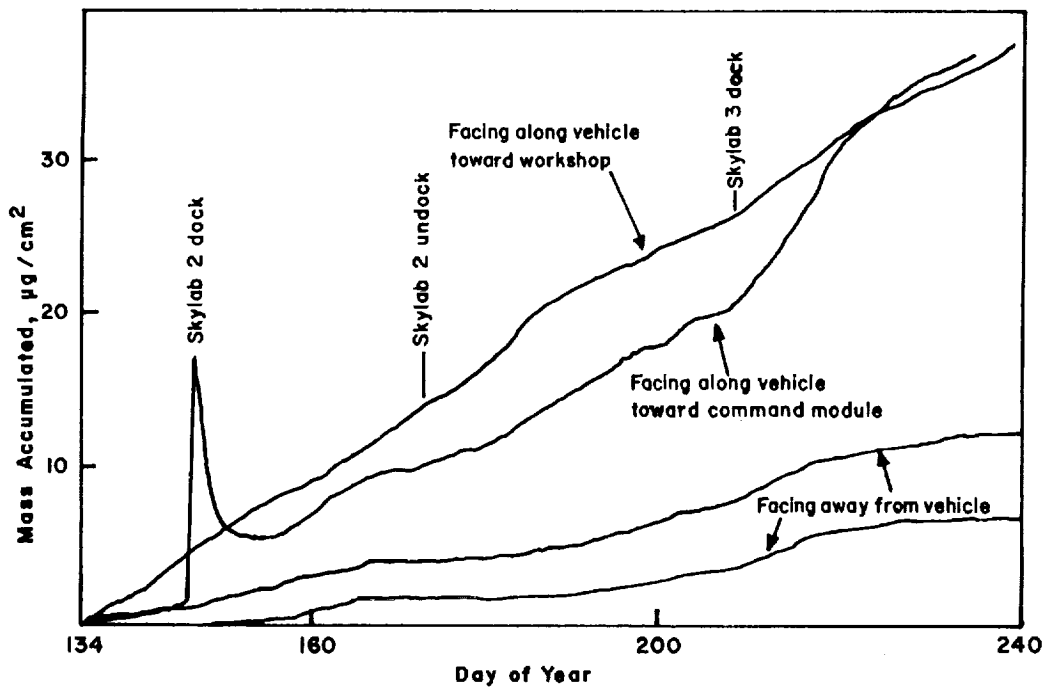
Figure 14. Histogram of Contamination for Skylab MDA

The contamination buildup as a function of time was measured by microbalances on the Skylab docking adapter. Crystals facing along the longitudinal axis registered the highest contamination rates. Crystals that faced away from the vehicle collected deposits presumably consisting of contaminants which originated from the space station and whose molecules were back-scattered by the atmosphere around the space station. Early in the mission, the crystal facing the command module was contaminated by the steering-rocket exhaust (ref. 3). A histogram is illustrated in figure 14.
