## Strength evaluation of prosthetic check sockets, copolymer sockets, and definitive laminated sockets

Maria J. Gerschutz, PhD;\* Michael L. Haynes, MS; Derek Nixon, BS; James M. Colvin, MS  
*The Ohio Willow Wood Company, Mt. Sterling, OH*

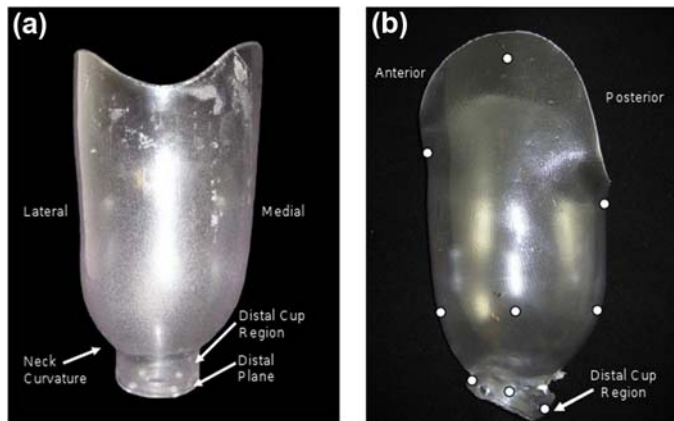
**Figure 1.**

(a) Sample check socket (CS) prior to static failure load testing with marked areas of interest. (b) Sample CS after static failure loading test. Socket thickness measurement sites indicated by dots. Only measurements sites visible in medial viewing plane are shown. Measurements taken prior to mechanical testing.

thickness measurements before mechanical testing. We conducted correlation analyses on thickness values measured along the middle of the distal cup region, which corresponded to the primary location of failure. Throughout the article, we refer to this measurement as the distal socket thickness.

All sockets failed in the distal cup region with the anterior portion in compression and the posterior portion in tension. **Figure 1(b)** pictures a static tested CS. All of the CSs but one failed in a ductile mode either by bending or tearing. The CPs typically bent, with 90 percent failing in a ductile mode. DLs all tore at the distal cup region in a brittle failure mode, exhibiting a failure of the fibers, the reinforcement material, and the resin.

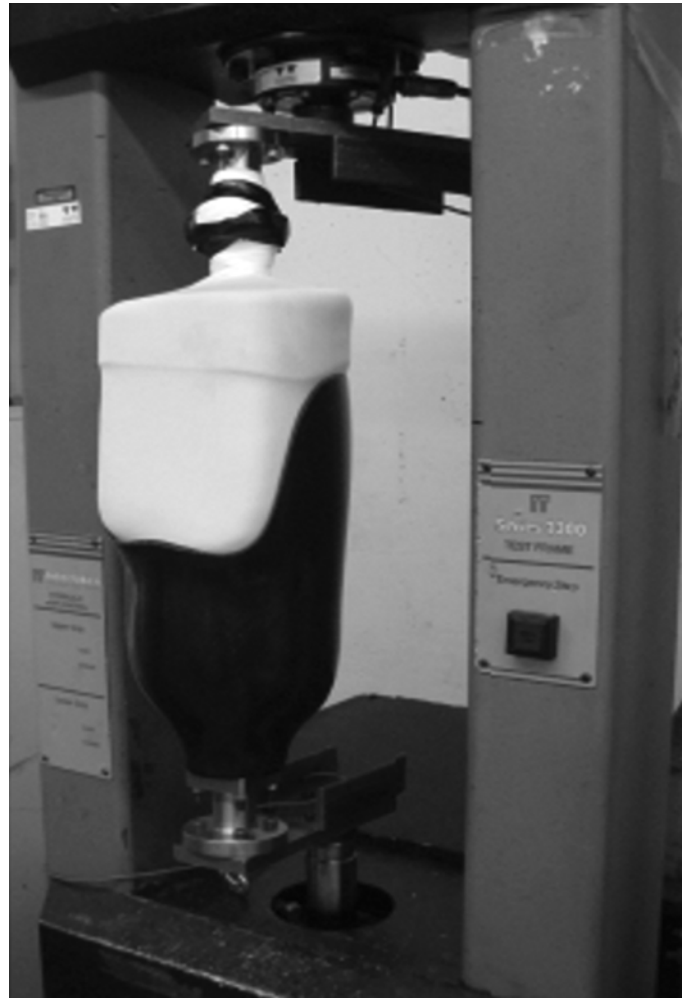
**Figure 2.**

Static socket testing configuration in accordance with International Organization for Standardization standard 10328.

We measured static failure loads using an Interlaken 3300 series test frame with a series 3200 controller (Interlaken Technology Corporation; Chaska, Minnesota). We conducted tests in accordance with ISO 10328 condition II by applying a 4.5 kg (10 lb) preload, then ramped the load to failure at a rate of 250 N/s. Passing criteria were considered to be the values designated in ISO 10328 condition II A125 level (4,426 N for brittle failure and 3,421 N for ductile failure). We attached the socket to the pylon using a standard four-hole distal attachment plate; the loads were transferred by a simulated residual limb model. A cone-shaped aluminum mandrel with a 5° tilt served as the core bone shape of the residual limb model. We casted the mandrel in a polyurethane (Repro One, Freeman Manufacturing & Supply Co; Avon, Ohio), allowing us to position a 9 mm uniform silicone liner between the residual limb model and the prosthetic socket. **Figure 2** presents a picture of the test setup. We noted any socket fit deviations in comparison with

the residual limb and liner condition before testing. The static failure test resulted in a force-deflection curve for each socket.

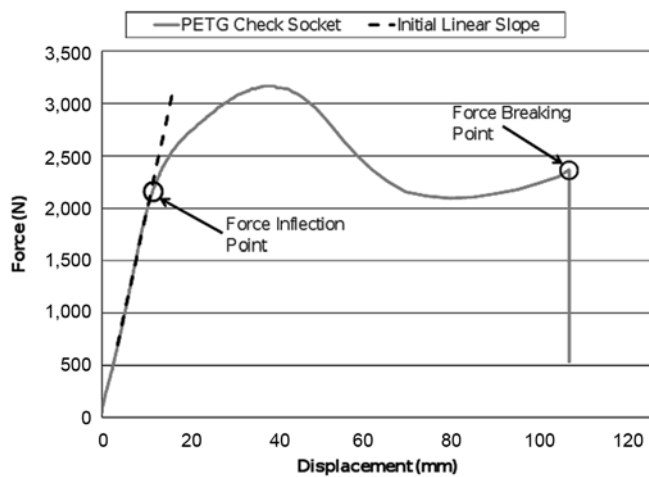
**Figure 3.**

Sample of force-deflection curve for polyethylene terephthalate glycol (PETG) check socket material. Force inflection point is determined using initial linear slope ( $R^2 > 0.995$ ) of curve and engineering definition of yield strength. Force breaking point is also indicated.

We analyzed the socket static testing by extracting the force inflection point on the force-deflection curve (**Figure 3**) that indicated yielding (the socket's yield strength). Using these force values, which represent the accumulation of permanent deformation that can lead to failure, we evaluated socket strength and analyzed the variance within a facility and the variance within the industry as a whole. We performed statistical computations using statistical software (JMP 8, SAS Institute, Inc; Cary, North Carolina) and conducted one-way analysis of variance (ANOVA) at a 5 percent significance level for

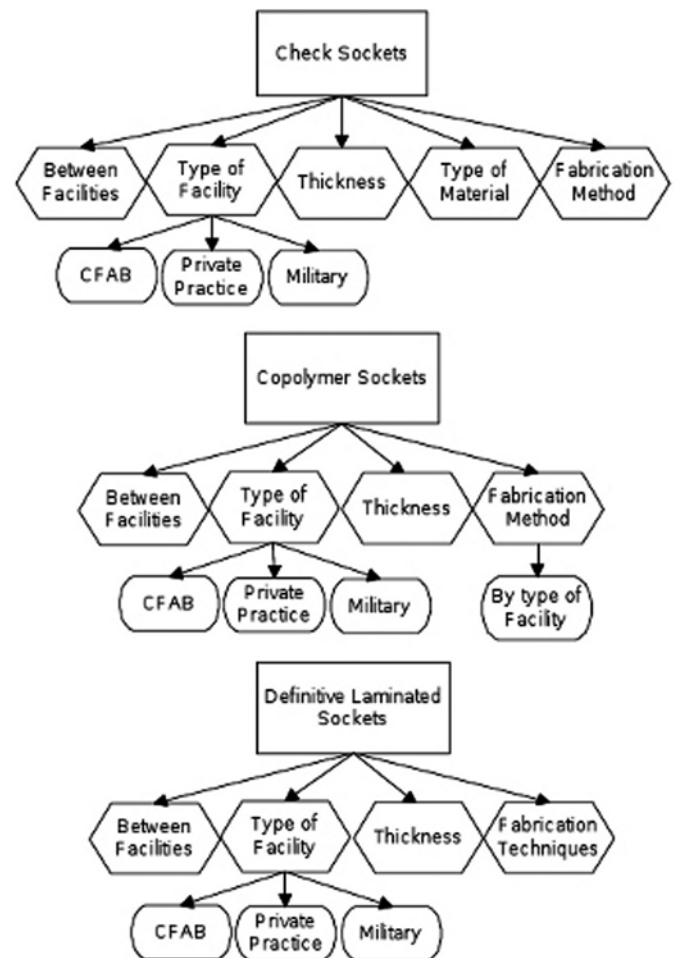
**Figure 4.**

Illustration of factors analyzed for each type of socket. CFAB = central fabrication.

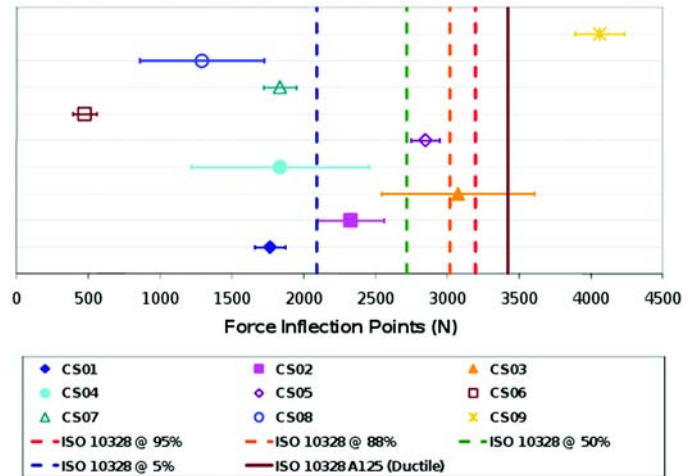
**Figure 5.**

Check sockets (CSs): mean  $\pm$  standard deviation of force inflection point for each facility. International Organization for Standardization (ISO) standard 10328 A125 ductile static test value along with anthropometric test values (95%, 88%, 50%, and 5%) are indicated with solid line and dotted lines, respectively.

**Figure 5** presents an initial comparison of each facility's average force inflection point and SD values. The results indicate that CSs from facilities 03, 05, and 09 had the highest average force inflection points. All three facilities used PETG material, and two used machine-

pulled fabrication methods. Facilities 06 and 08 had the lowest average force inflection points. The results also showed that facilities 04 and 08 had the largest variability, with RSDs averaging above 30 percent. The ISO 10328 anthropometric percentiles at 95, 88, 50, and 5 for a ductile failure mode are indicated on the graph with dotted lines, and the ISO 10328 ultimate ductile static test force (passing criterion of 3,421 N) is indicated by the solid line (**Figure 5**). Only one facility's averages (facility 09) exceeded the ISO 10328 A125 ductile static test force.

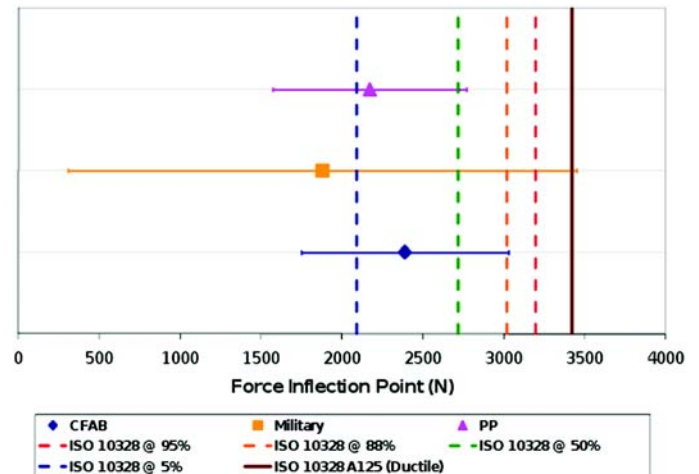
**Figure 6.**

Check sockets mean  $\pm$  standard deviation comparison for type of facilities (central fabrication [CFAB], private practice [PP], and military). International Organization for Standardization (ISO) standard 10328 A125 ductile static test value along with anthropometric test values (95%, 88%, 50%, and 5%) are indicated with solid line and dotted lines, respectively.

We also analyzed CSs by type of facility: CFAB, PP, and military. We detected no difference in static failure loads ( $p = 0.49$ ) between the types of facilities. **Figure 6** contains the mean  $\pm$  SD values for each type of facility. The highest amount of variability (84% RSD) occurred between the military facilities.

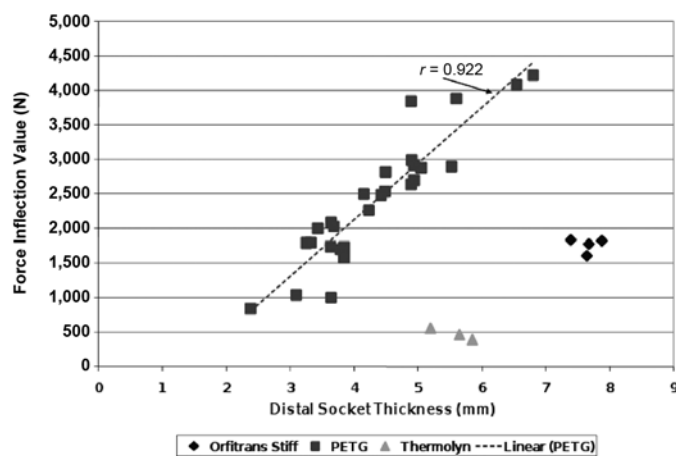
**Figure 7.**

Check socket force inflection point versus distal thicknesses for check sockets grouped by material type. PETG = polyethylene terephthalate glycol.

the force inflection values and distal socket thicknesses for each material type. **Figure 7** shows a graphical relationship. We found a correlation between the force inflection points and distal socket thickness for PETG material ( $r = 0.92$ ). Since ThermoLyn rigid and Orfitrans Stiff materials were provided by only one facility each, we did not analyze correlation with thickness. However, sockets made from ThermoLyn rigid and Orfitrans Stiff appear to follow the same thickness trend line and were found to have similar mechanical properties in another study [10]. **Figure 7** illustrates that sockets made from ThermoLyn rigid and Orfitrans Stiff materials required thicker distal socket walls to produce inflection forces comparable with sockets made from PETG materials. **Table 4** lists the number of sockets constructed from each type of material. Four PETG CSs were constructed with medial lock holes that we did not specify in the original fabrication instructions. Therefore, we constructed an additional

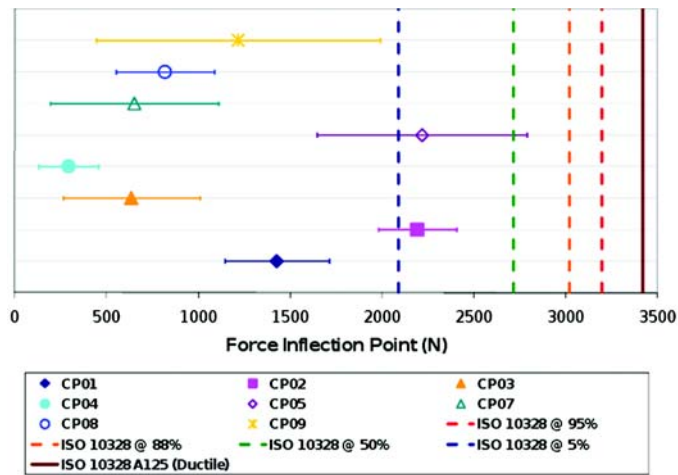
**Figure 9.**

Mean  $\pm$  standard deviation of force inflection point for each facility's copolymer sockets (CPs). International Organization for Standardization (ISO) standard 10328 A125 ductile static test value along with anthropometric test values (95%, 88%, 50%, and 5%) are indicated with solid line and dotted lines, respectively.

sockets. The results indicate that CPs from facilities 02 and 05 had the highest average force inflection points. In contrast, facilities 03, 04, 07, and 08 had the lowest average force inflection points. Facilities 03, 04, 07, and 09 had the highest amount of variability, with RSDs ranging from 56 to 70 percent. The ISO 10328 A125 passing force for ductile static testing and anthropometric percentiles for a ductile failure mode are indicated in **Figure 9**. None of the facilities' averages exceeded the ISO 10328 at the 50 percent anthropometric level; thus, all sockets failed the ISO 10328 A125 static test for ductile materials. Only two facilities (02 and 05) had sockets surpass ISO 10328 loading criteria at the 5 percent anthropometric level.

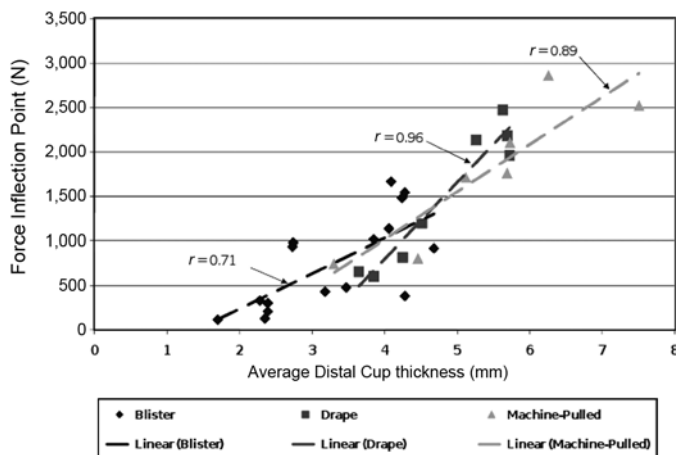
**Figure 10.**

Correlation between force inflection points and average distal socket thicknesses for copolymer sockets categorized by fabrication method.

To further understand the effects of fabrication, we investigated the effect of distal socket thickness on force inflection points for all data. Since all sockets were constructed with copolymer material, we also evaluated data for all sockets as a group. The overall correlation coefficient between force inflection points and average distal socket thickness was 0.88 when we lumped together all data for all fabrication methods. We observed a strong correlation for drape ( $r = 0.96$ ) and machine-pulled fabrication ( $r = 0.89$ ). A less significant correlation was present for blister fabrication ( $r = 0.71$ ). **Figure 10** displays the correlation categorized by fabrication method.

We observed a correlation between average distal thickness and force inflection points for a given fabrication method. According to the trend in **Figure 10**, sockets fabricated with the drape method appear to be influenced

more by distal socket thickness than the other fabrication methods. This may be because the additional material left in these sockets to form a seam also forms a thicker section that can act as a load-bearing member in the overall structure. In order to satisfy the anthropometric 95 percent ISO 10328 ductile failure mode criterion, the correlation between distal thickness and force inflection points suggests a copolymer distal (cup) thickness greater than 7.3 mm would be necessary.

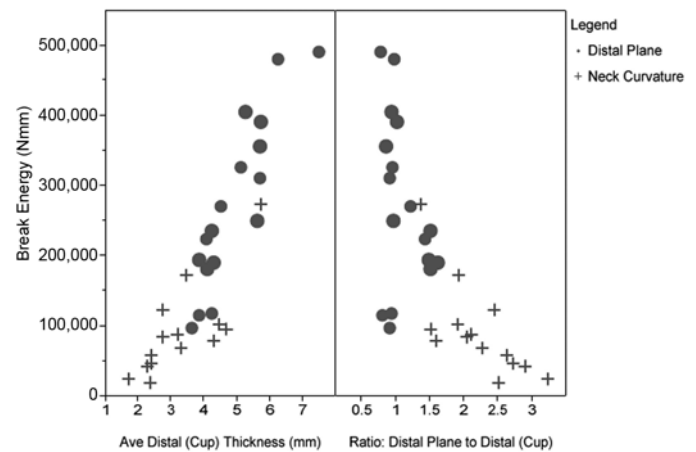
**Figure 11.**

Copolymer sockets: breaking energy versus average distal (cup) thickness and break energy versus ratio between distal plane thickness and distal (cup) thickness. Location of ductile compression is indicated either at socket's neck curvature (+) or at distal plane where distal adapter is attached (●). **Figure 1(a)** illustrates socket location of distal cup, neck curvature, and distal plane. Ave = average.

A majority of the CPs failed in a ductile mode with signs of either compression at the socket's anterior neck curvature or compression at the distal plane (adapter attachment site). We observed a correlation ( $r = 0.89$ ) between break energy and distal (cup) thickness (**Figure 11**). We also observed an additional trend (correlation  $r = 0.73$ ) between break energy and the ratio of the distal plane thickness to the distal cup thickness (**Figure 11**).

The correlation between break energy and distal cup thickness (**Figure 11**) suggests that more favorable outcomes (ductile distal compression with high break energy) occurred at distal cup thicknesses greater than 5 mm. Additionally, the correlation between break energy and the ratio of the distal plane thickness to the distal cup thickness (**Figure 11**) indicates that a ratio of 1.5 appears to be the transition area between compression at the distal plane and compression at the socket's neck curvature. Ratios below 1.5 tend to result in distal plane compression, a more favorable failure location. While this value is likely to depend on the geometry of the specific socket, this further highlights the complexities of the trade-offs that the industry currently faces.

evidence currently seems to indicate that thicker sections of some of the thermoformable materials are more susceptible to brittle failures and the resulting sharp features caused by such failures (**Figures 8 and 11**).

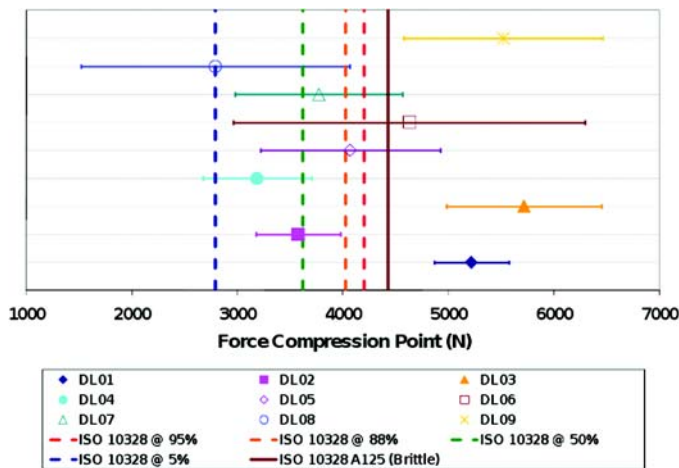
**Figure 12.**  
Mean  $\pm$  standard deviation of force compression point for each facility's definitive laminated sockets (DLs). International Organization for Standardization (ISO) standard 10328 A125 brittle static test value along with anthropometric test values (95%, 88%, 50%, and 5%) are indicated with solid line and dotted lines, respectively.

The first analysis compared individual facilities. **Figure 12** presents a graphical depiction of the mean  $\pm$  SD of the force compression point for each facility. The ISO 10328 A125 brittle failure mode static test criterion (4,426 N) and the anthropometric percentiles at 95, 88, 50, and 5 percent are indicated on the graph with a solid line and dotted lines, respectively. The results show that DLs from facilities 01, 03, and 09 had the highest averages. The results also indicate that facilities 05, 06, 07, and 08 had the highest amount of variability, with RSD values ranging from approximately 21 to 46 percent. Facilities 01, 03, 06, and 09 produced averages at or above the anthropometric 95 percent ISO 10328 level; however, the SD for facility 06 extends below the anthropometric 50 percent ISO 10328 level. Two facilities, 04 and 08, had variances below the anthropometric 5 percent ISO 10328 level. The averages of five facilities

below the solid line (02, 04, 05, 07, and 08) failed to pass the A125 ISO 10328 brittle static test force.

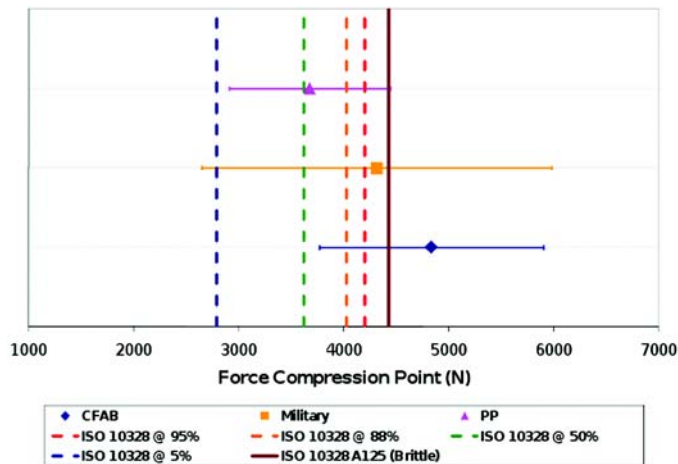
**Figure 13.** Definitive laminated sockets: mean  $\pm$  standard deviation comparison for type of facilities (central fabrication [CFAB], private practice [PP], and military). International Organization for Standardization (ISO) standard 10328 A125 brittle static test value along with anthropometric test values (95%, 88%, 50%, and 5%) are indicated with solid line and dotted lines, respectively.

DLs had force compression values ranging above the anthropometric 50 percent ISO 10328 level. The SD for the PP DLs extended below the anthropometric 50 percent ISO 10328 level, and the SD for the military DLs extended below the anthropometric 5 percent ISO 10328 level.
