Relationship between New Osteoporotic Vertebral Fracture and Instrumented Lumbar Arthrodesis

Bung-Hak Kim, Dong-Hyuk Choi, Seong-Hun Jeon, Yong-Soo Choi

Department of Orthopaedics, Kwangju Christian Hospital, Gwangju, Korea

Study Design: Retrospective study.

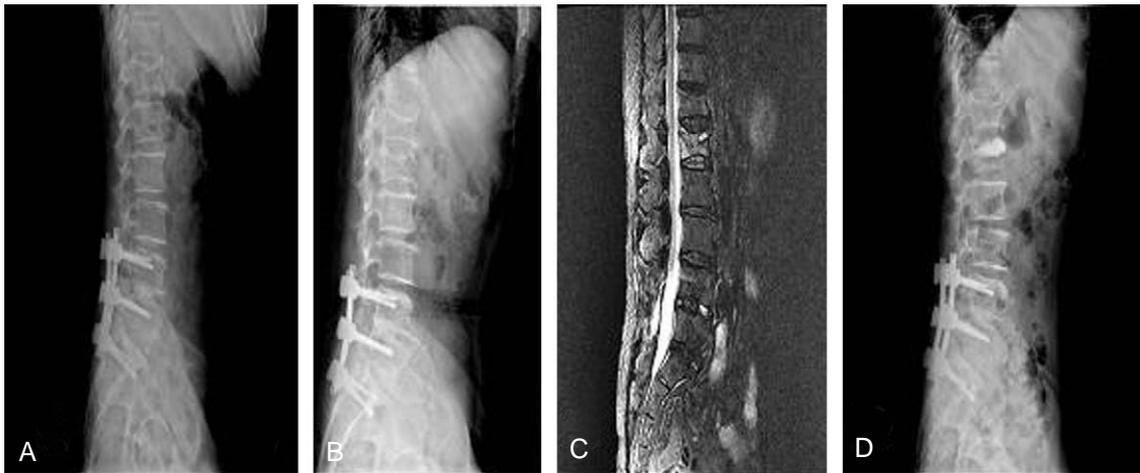
Fig. 1. A 66-year-old female radiographs. (A) Instrumented posterior lumbar interbody fusion was done for spinal stenosis. (B) At postoperative 16months, L1 compression fracture was developed after slip down. (C) Lumbar magnetic resonance imaging with T2 image shows signal change at L1 body. (D) Kyphoplasty was done at L1 body because of continuous back pain in spite of conservative therapy.

The osteoporotic vertebral fracture in both groups was treated with bed rest and pain medication in the early stages. After resolving the extreme pain, early ambulation with a brace was recommended. If the pain continued for more than 2 or 3 weeks, vertebroplasty was performed with bone cement in 2 cases (Fig. 1). After 8 to 12 weeks of brace application, muscle strengthening exercise and reforming the mode of living and osteoporotic medication were recommended.

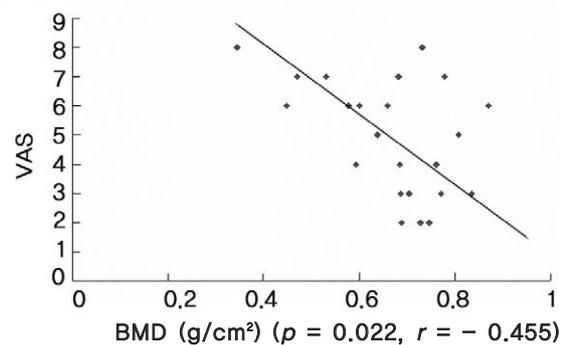
Fig. 2. There was a statistically negative correlation between the bone mineral density (BMD) of femoral neck and the back pain at the last follow up ($r = -0.455$, $p = 0.022$). VAS: Visual analogue score.

revealed an average of $22.8 \pm 10.9^\circ$ at the time of the fracture and $24.2 \pm 10.1^\circ$ at 1 year after fracture. There was no significant change in radiological height loss of the fracture and lumbar lordosis at 1 year after the fracture. In addition, there was no significant correlation between back pain and the loss of vertebral height ($r = -0.198$, $p = 0.342$), back pain and lumbar lordosis ($r = 0.070$, $p = 0.741$) at the last follow up. On the other hand, there was significant negative correlation between the BMD of the femoral neck and back pain at the last follow up ($r = -0.455$, $p = 0.022$) (Fig. 2).
