Diagnostic performance of cone-beam computed tomography on detection of mechanically-created artificial secondary caries

Arnon Charuakkra, Sangsom Prapayasadok, Apirum Janhom, Surawut Pongsiriwet, Karune Verochana, Phattaranant Mahasantipiya

Division of Oral and Maxillofacial Radiology, Department of Oral Biology and Diagnostic Sciences, Faculty of Dentistry, Chiang Mai University, Chiang Mai, Thailand

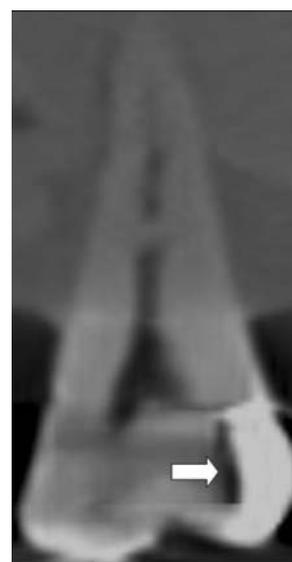
Fig. 6. The CBCT image in the sagittal plane shows the artifacts (arrow) from the adjacent amalgam restoration that could be misinterpreted as secondary or remnant caries.

Remnant caries can be sometimes considered as secondary caries. In this study, secondary caries was defined as a type of caries occurring at the margin of an existing restoration.¹⁰ From our observation, the artifacts seen as dark streaks beneath the amalgam restoration were usually revealed on the CBCT images; consequently, the artifacts could be misinterpreted as secondary or remnant caries (Fig. 6).

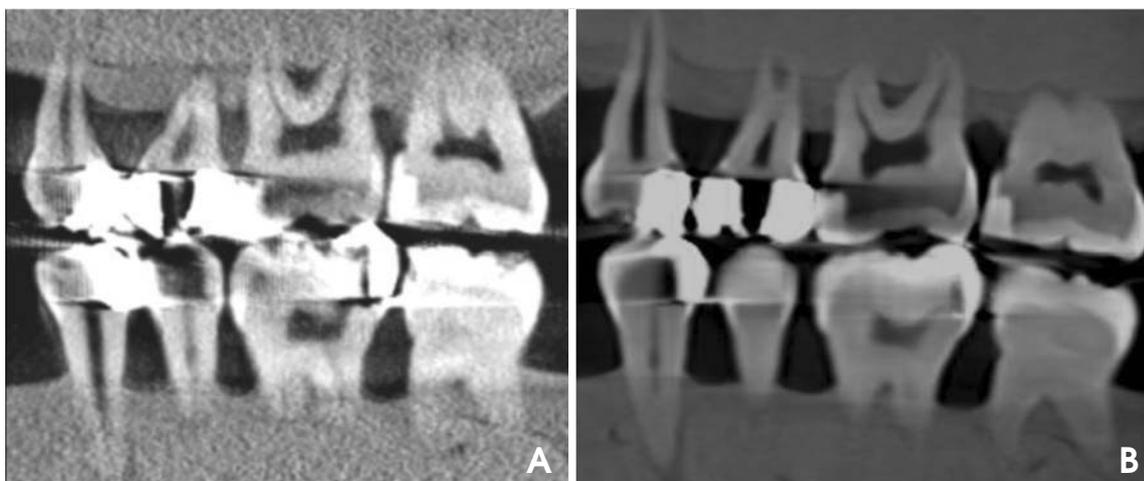
Fig. 7. The Promax 3D system CBCT image (A) demonstrates a greater amount of artifacts than that of the Pax-500ECT system (B).

of proximal enamel and dentin caries. In our study, the Pax-500ECT system demonstrated higher A_z values than those of the Promax 3D for the diagnostic accuracy of secondary caries. The Pax-500ECT system has a smaller FOV (5 × 5 cm) than that of the Promax 3D (8 × 8 cm). Two pairs of dental blocks were radiographed in the Promax 3D system, whereas only one pair was radiographed in the Pax-500ECT, due to its limited FOV. Accordingly, the artifacts from one side may affect the image of the other side, resulting in lower A_z values. In addition, more artifacts were observed in the Promax 3D system than in the Pax-500ECT system (Fig. 7).
