Oxygen Cylinders: “life” or “death”?

Sanjay Gupta, C.B.Jani

Forensic Medicine Department, P.S. Medical College, Karamsad – 388 325, (Gujarat), India.

African Health Sciences 2009; 9(1):57-60

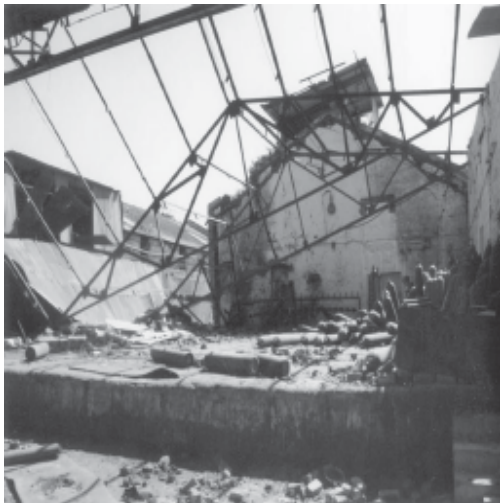
Pieces of exploded cylinder were found up to 40 ft within premises, damaged wall at a distance of 25 ft and completely destroyed roof sheets at 25 ft height associated with collapse of roof frame (Photograph-1). Human remains were found in a radius of 25 ft area in scattered manner, among structure debris.

Photograph-1: Collapsed roof structure along with scattered intact cylinders.

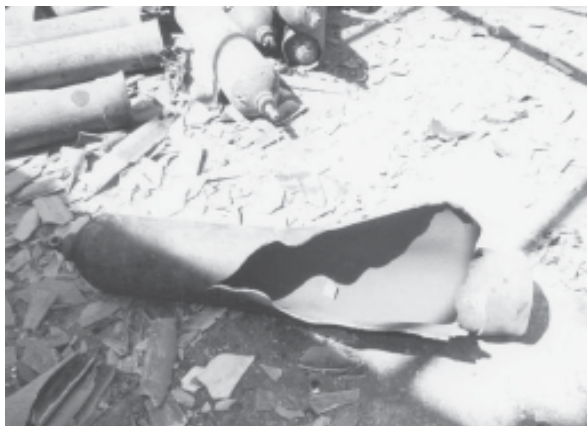
Fortunately the fragment of exploded cylinder (Photograph-2) impacted only one empty cylinder near by and no other filled cylinder, or else the quantum of damage would have been quite higher than what had occurred.

Photograph-2: Closer view of partially burst open cylinder with brownish discoloration due to rust formation on the inner surface.

7.	Don't completely empty the cylinder ¹¹ .	Cooled empty cylinder will allow environmental air to enter cylinder, rust can form inside the pressure vessel and weaken it.	Probably yes, A. Brownish dust like material (rust) was found on the body of all 3victims. B. The partially burst open cylinder showed similar rust on the inner wall of cylinder.

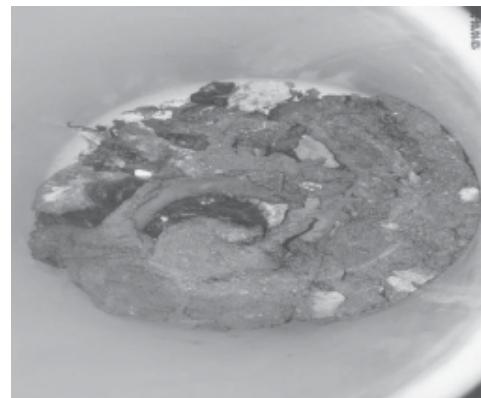
Extremely mutilated, charred and separated remains weighing about 10 kg of a male –32 years, (Gathered in a yellow color tub-bucket) comprising of: (1) Scalp attached to some pieces of left side skull vault and facial skin attached to left half of mandible (with 8 teeth). (2) Piece of right mandible (with 7 teeth). (3) Five thoracic vertebra in one with attached pieces of ribs. (4) 15x10cm skin flap of anterior abdominal wall. (5) Two lumbar vertebra in one piece. (6) Three lumbar vertebra in one piece. (7) Acetabular fragment of right hip joint. (8) Acetabular fragment of left hip joint. (9) Fragment of right elbow joint. (10) Great toe (side not opened). (11) Unidentifiable soft tissue masses with bone remnants. (Photograph-3). All above stated materials were completely separated with each other and brownish granular material was sticking to uncharred areas.

Photograph-3: Charred and separated remains stained with brownish granular material of victim-1(male aged 32 years) which were gathered in a yellow color tub-bucket.

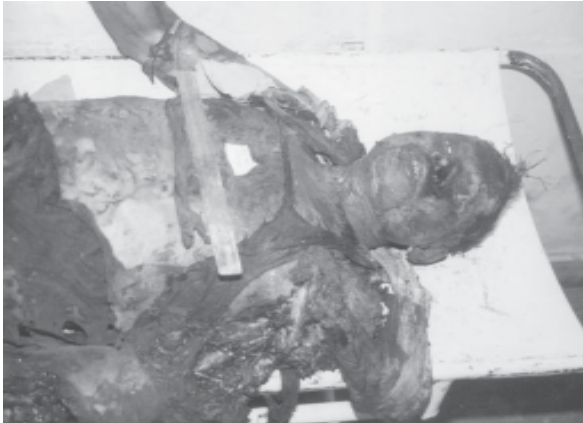
Dead body of a male –40 years old with burnt & torn clothes on front, brown red color granular material over front aspects of body, and bright red color bloodstains on head, face, left shoulder & trunk. Following injuries were found: (Photograph-4)

[a] Thermal: Dermo-epidermal ante mortem burns (involving 85% of total surface area of the body as per rule of nines⁹) sparing back of trunk with soot particles in trachea and singeing effect was present on scalp hair, eyelashes, eyebrows and mustache.

[b] Mechanical: (1) Left shoulder with upper third of arm showed disruptive laceration with fractures of underneath bones. (2) Multiple irregular puncture wounds and abrasions all over front aspects of body. (3) Diffuse subarachnoid haemorrhage. (4) “Blast lung” effect in both lungs in form of irregular subpleural hemorrhages with contusions in deeper substance.

Photograph-4: - Male, aged 40 years (victim-2) with features of dermo-epidermal burns, stained with brownish granular material, torn clothes and disruptive mechanical injury at left shoulder region.
